2016 Vedder River Gravel Removal Issue—  
November 2017 Agency-Public Review

Stewardship Meeting with Agencies

November 27, 2017

THE MANAGEMENT OF SEDIMENT REMOVALS TO LONG TERM AVERAGE IS NOT DEFENSIBLE BECAUSE THE SEDIMENT VOLUMES HAVE BEEN DECLINING SINCE 2006 (KWL 2006) AND THE RIVER IS NOW ENTERING A STATE OF DEEP DEGRADATION DUE TO HISTORIC OVER-EXTRACTION AND LOW NATURAL INPUTS

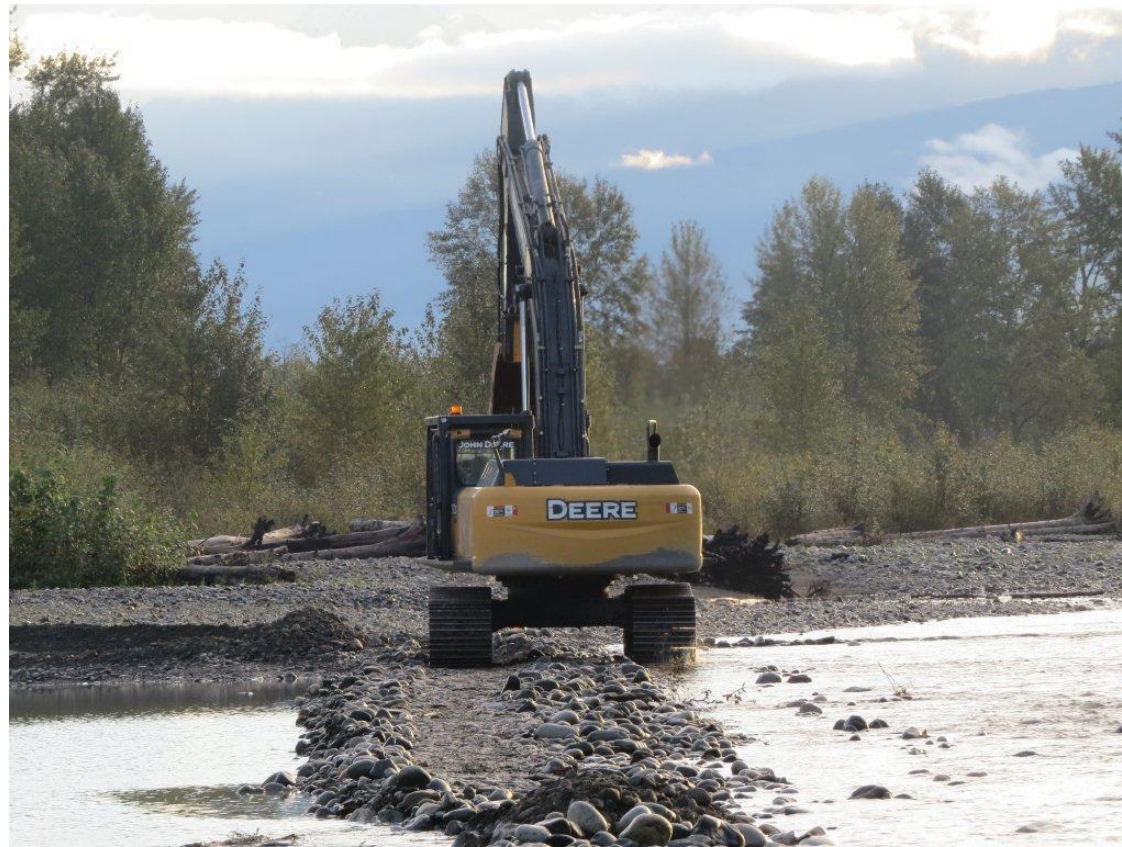
Entrainment of fine sediments into the stream due to the works—why was equipment allowed to work in the stream and create berms after flooding had started?

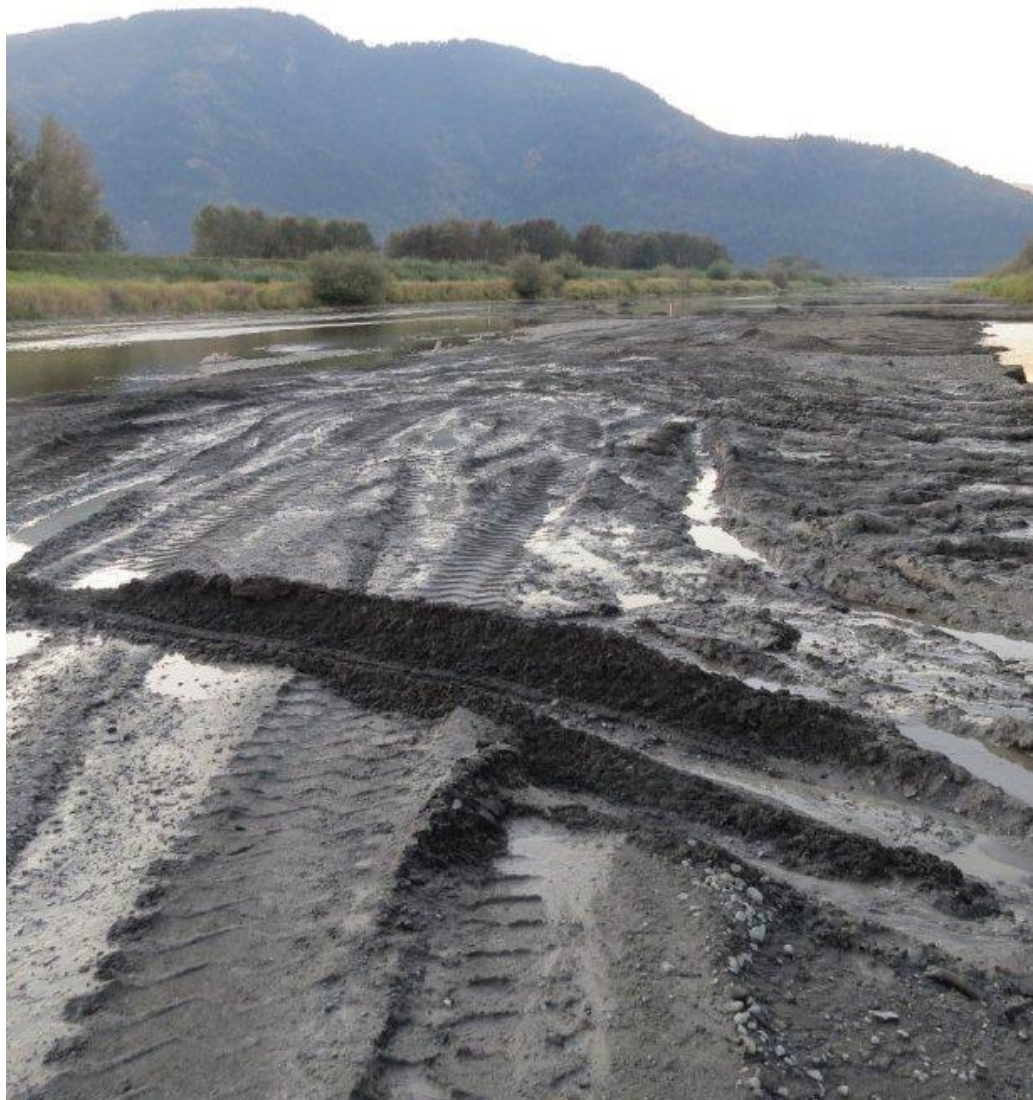
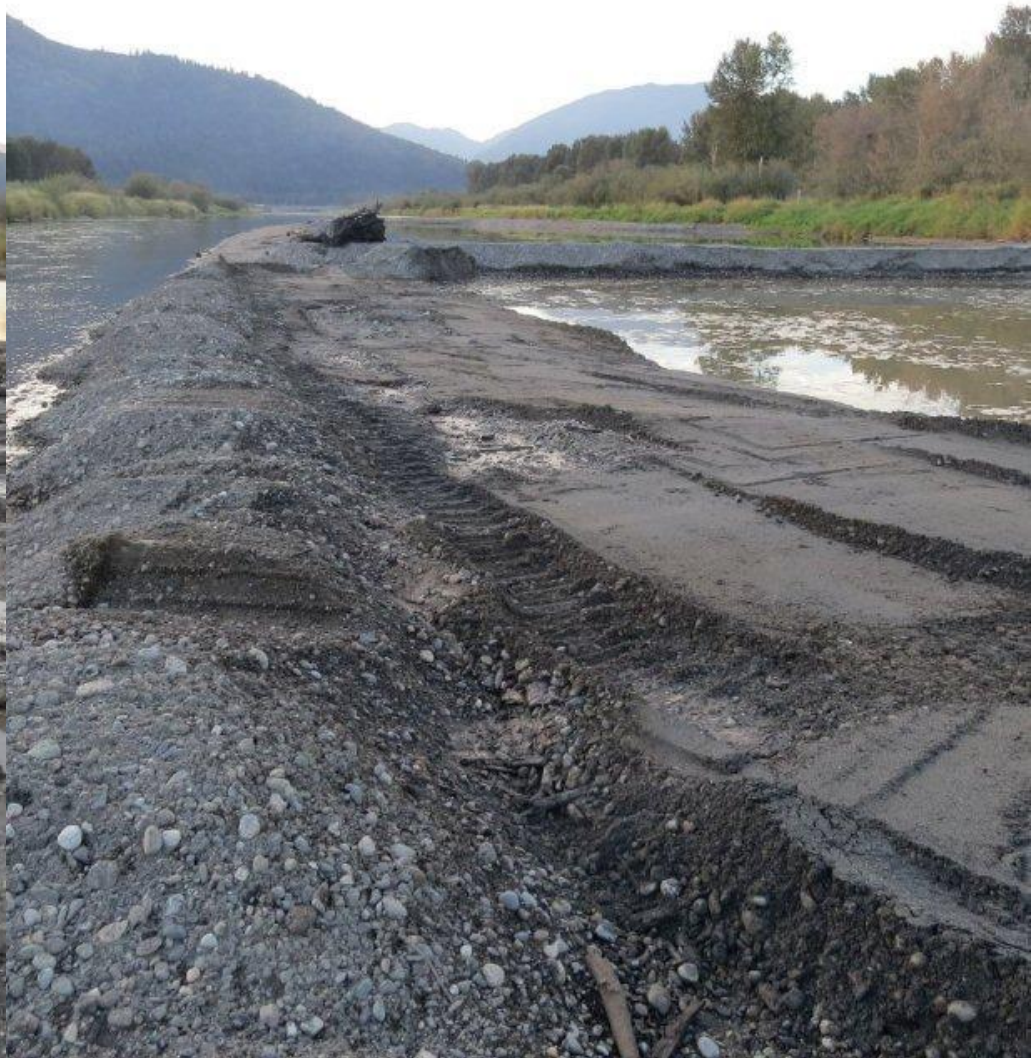
Why are there no silt fences or sediment abatement coverings?

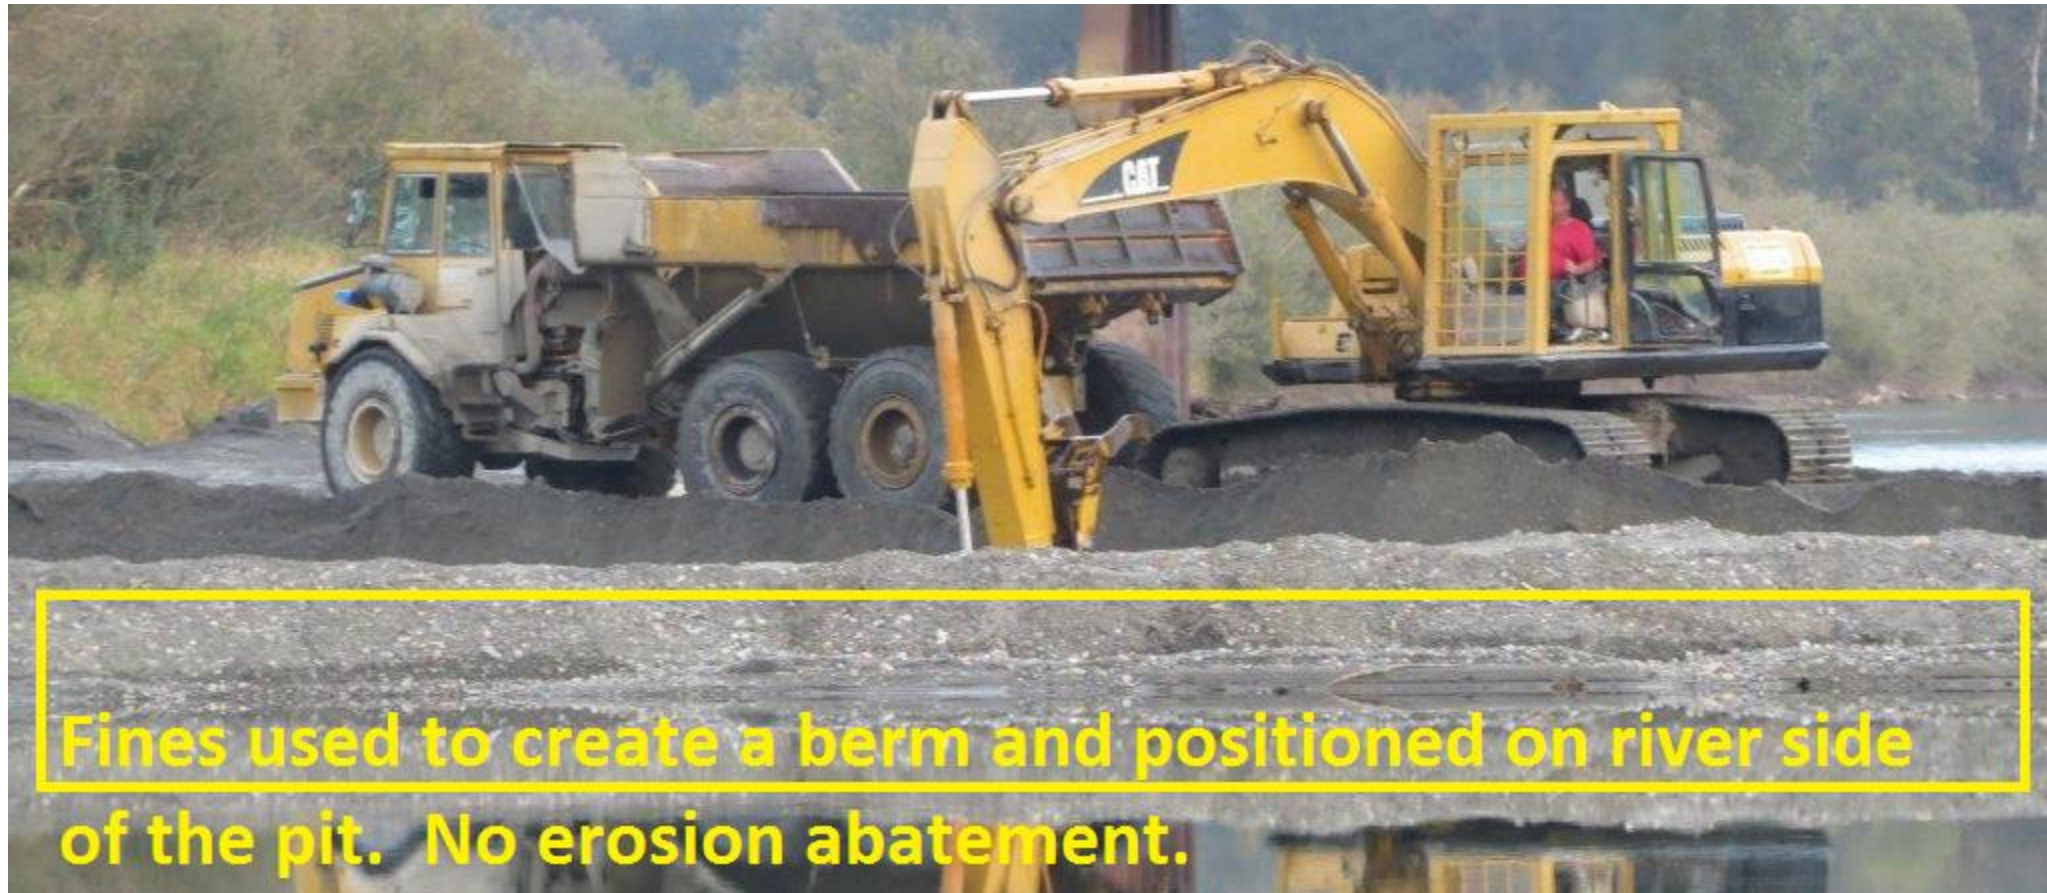
Poor sediment management—using a berm of fine silt and gravel to isolate an extraction site

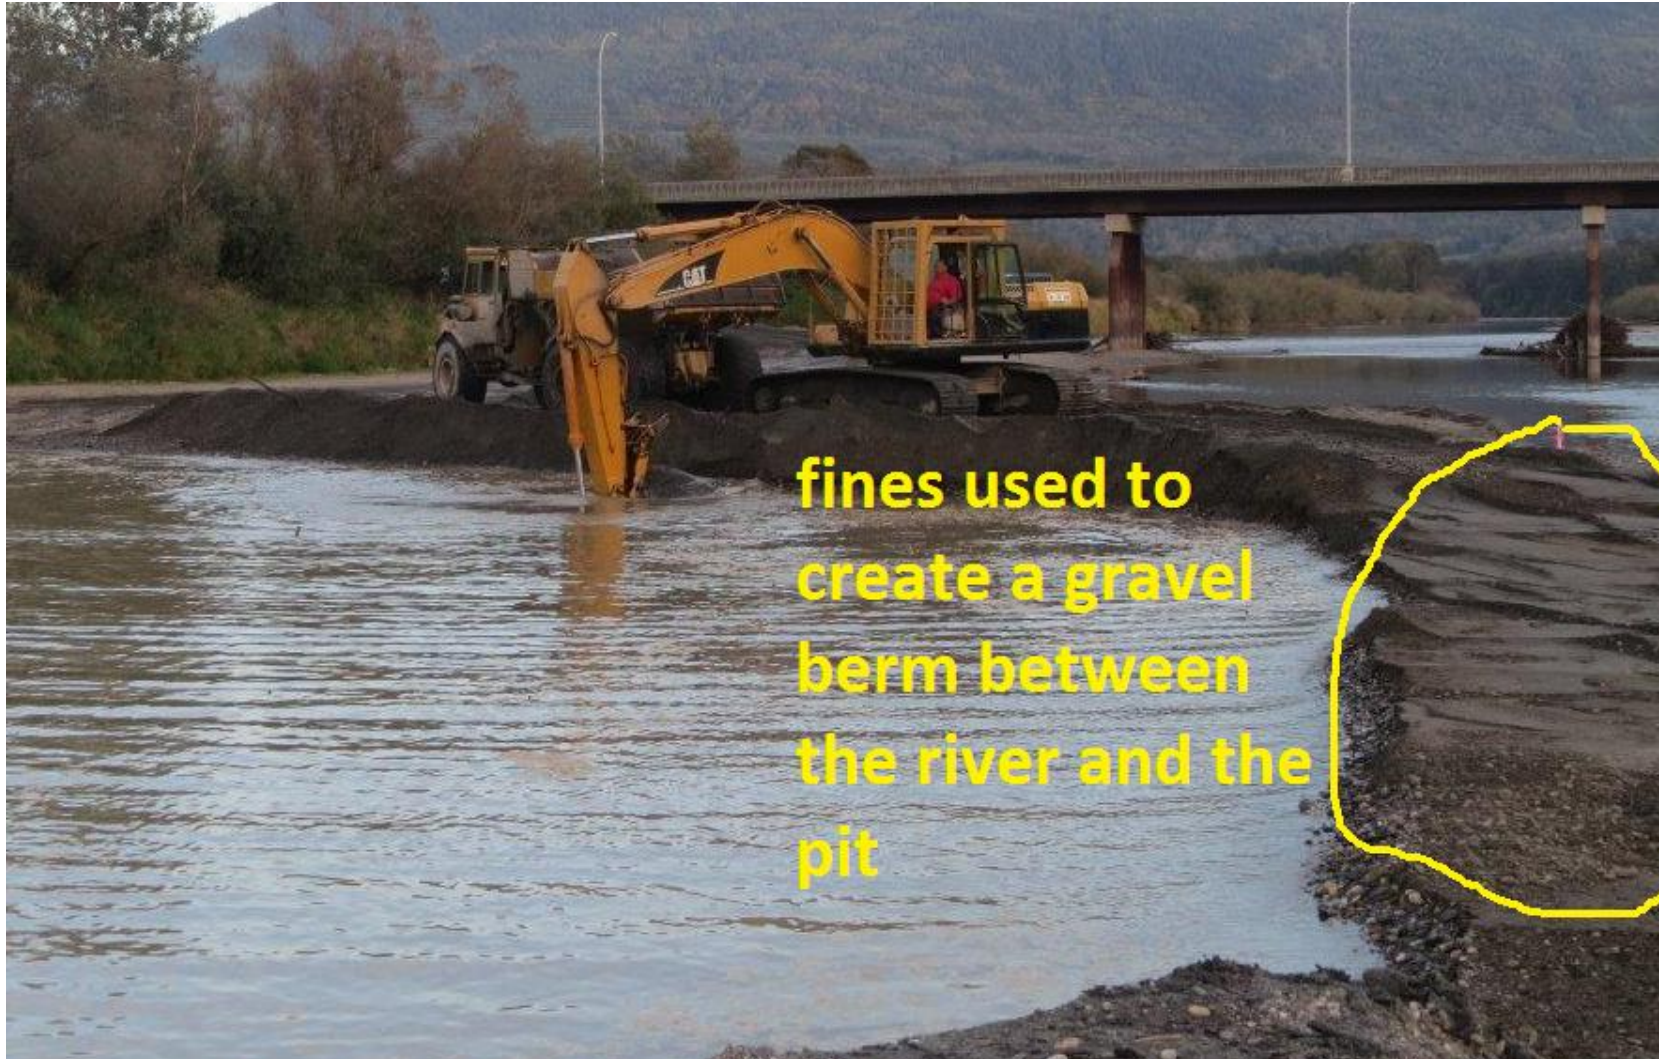
# Using silt as a berm between the project and stream

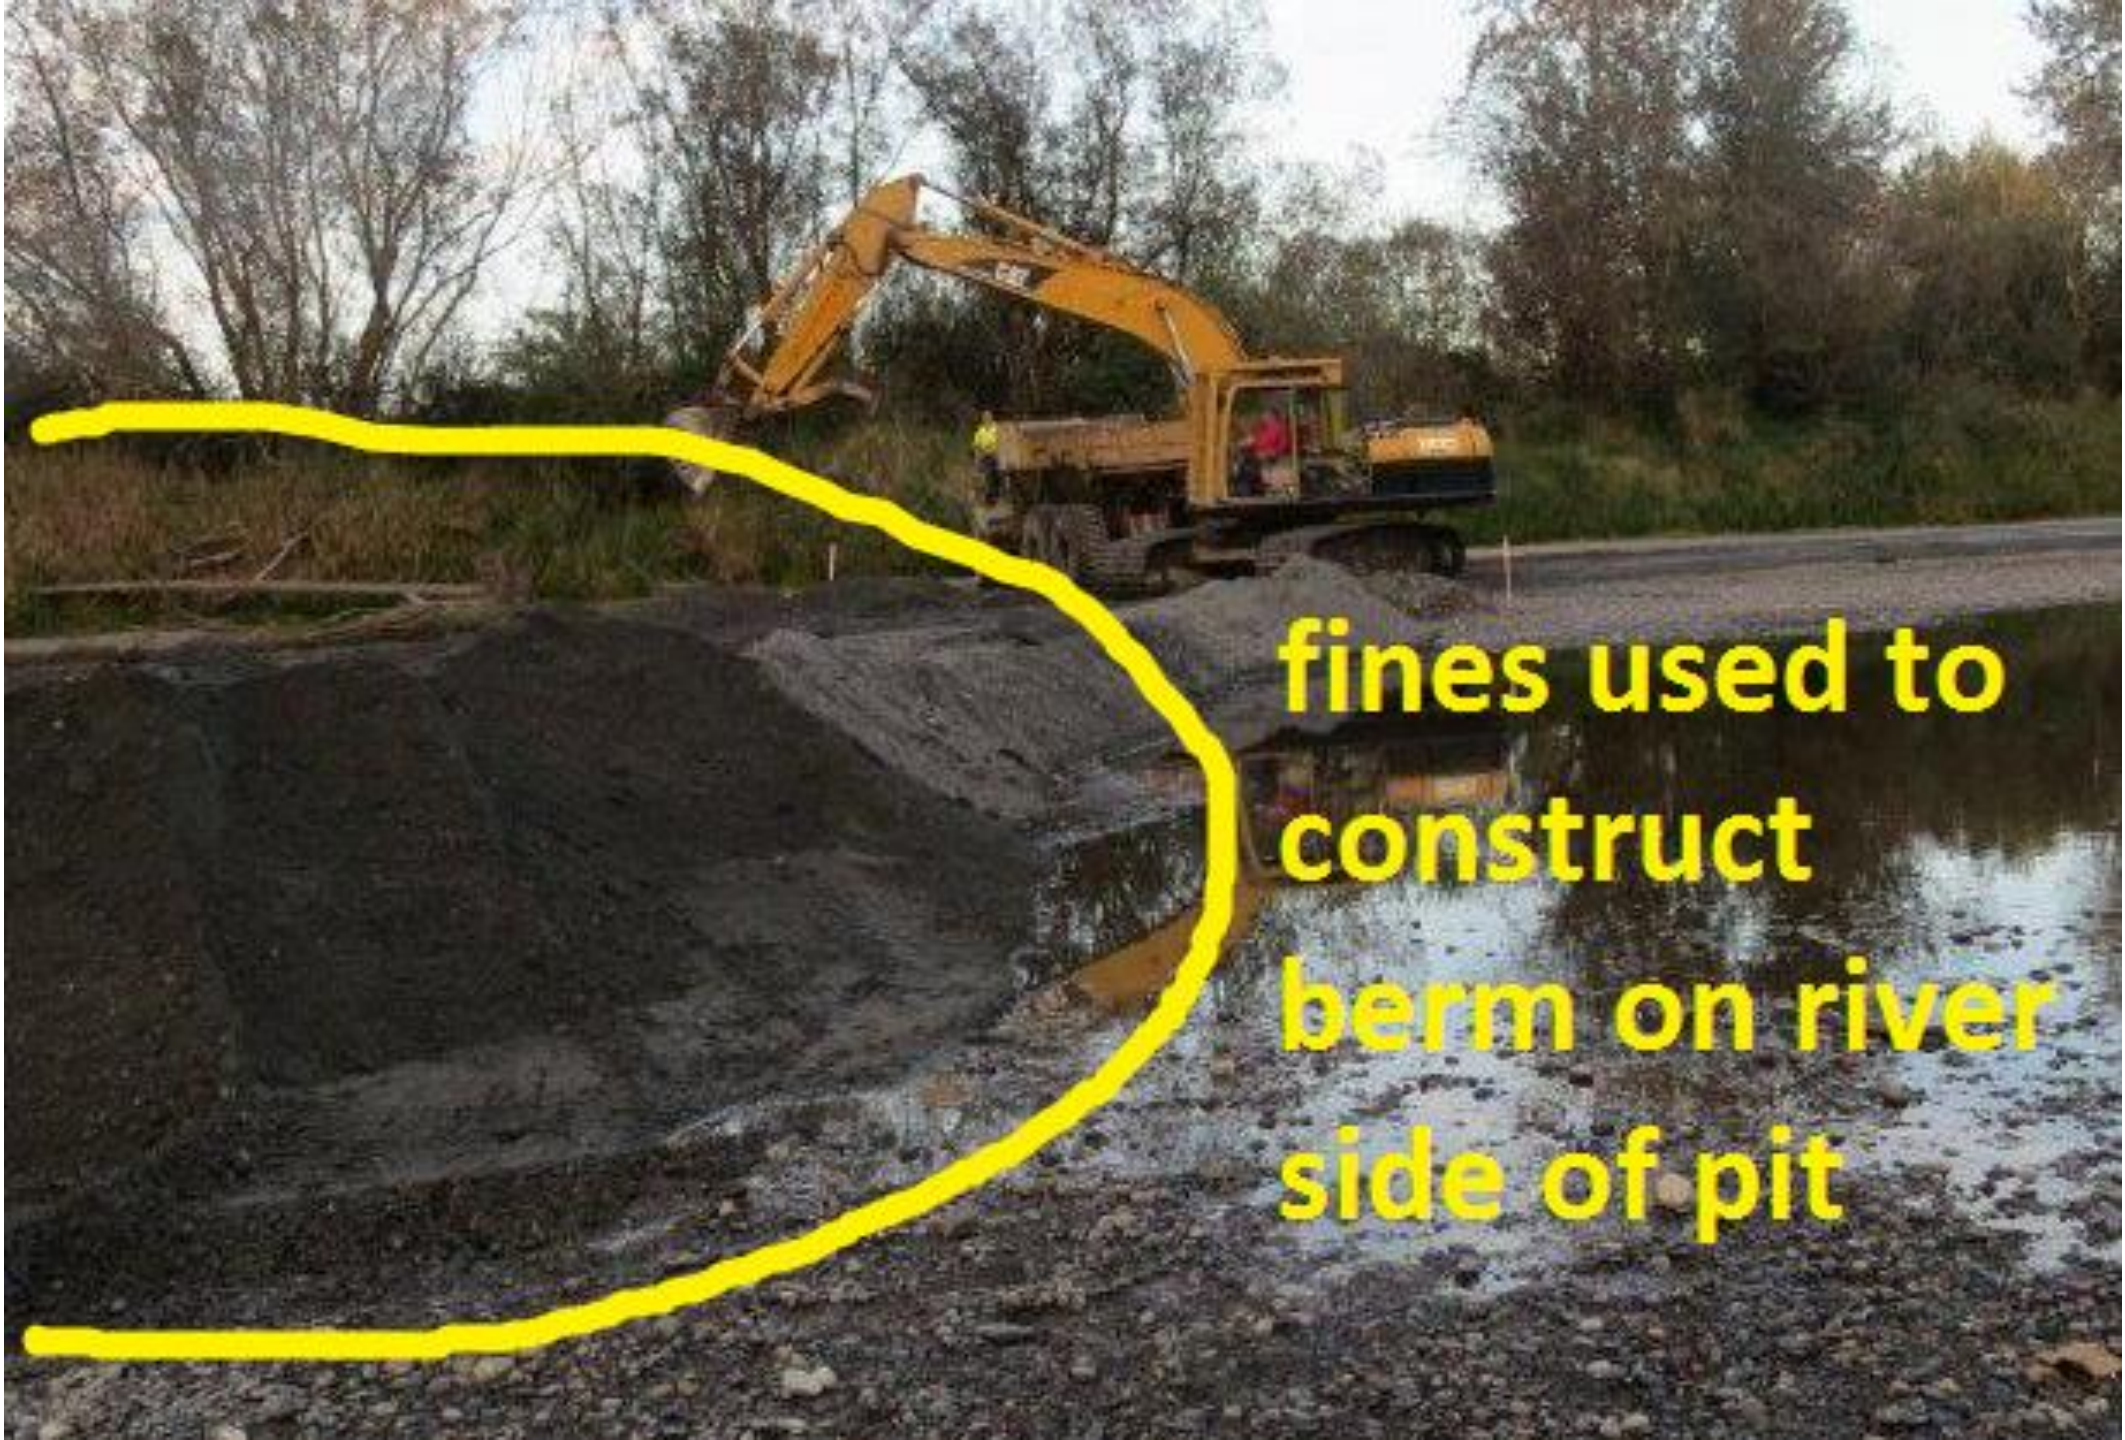
**fines used to  
create a gravel  
berm between  
the river and the  
pit**

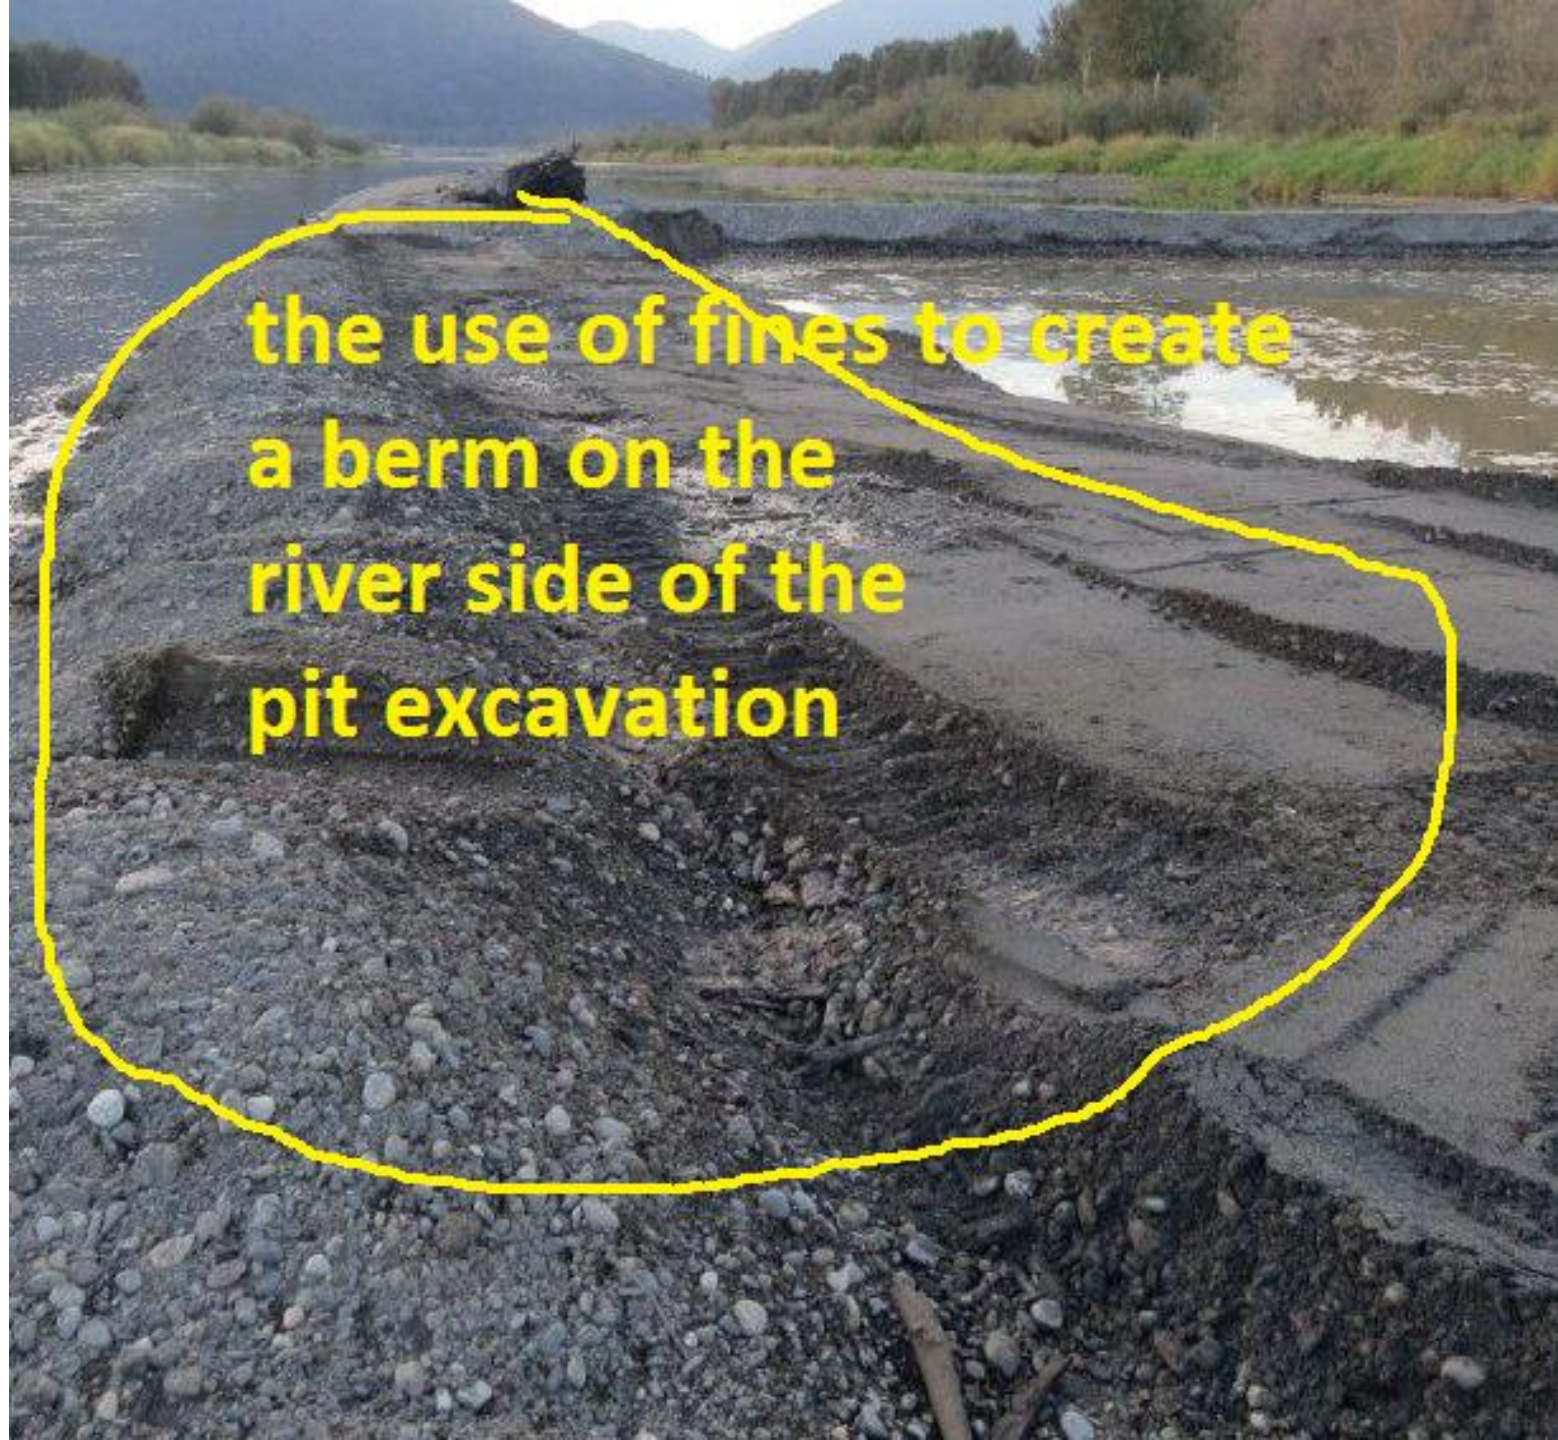
**finer used to  
construct  
berm on river  
side of pit**

Bad silt  
management  
—no  
sediment  
erosion  
abatement  
structures

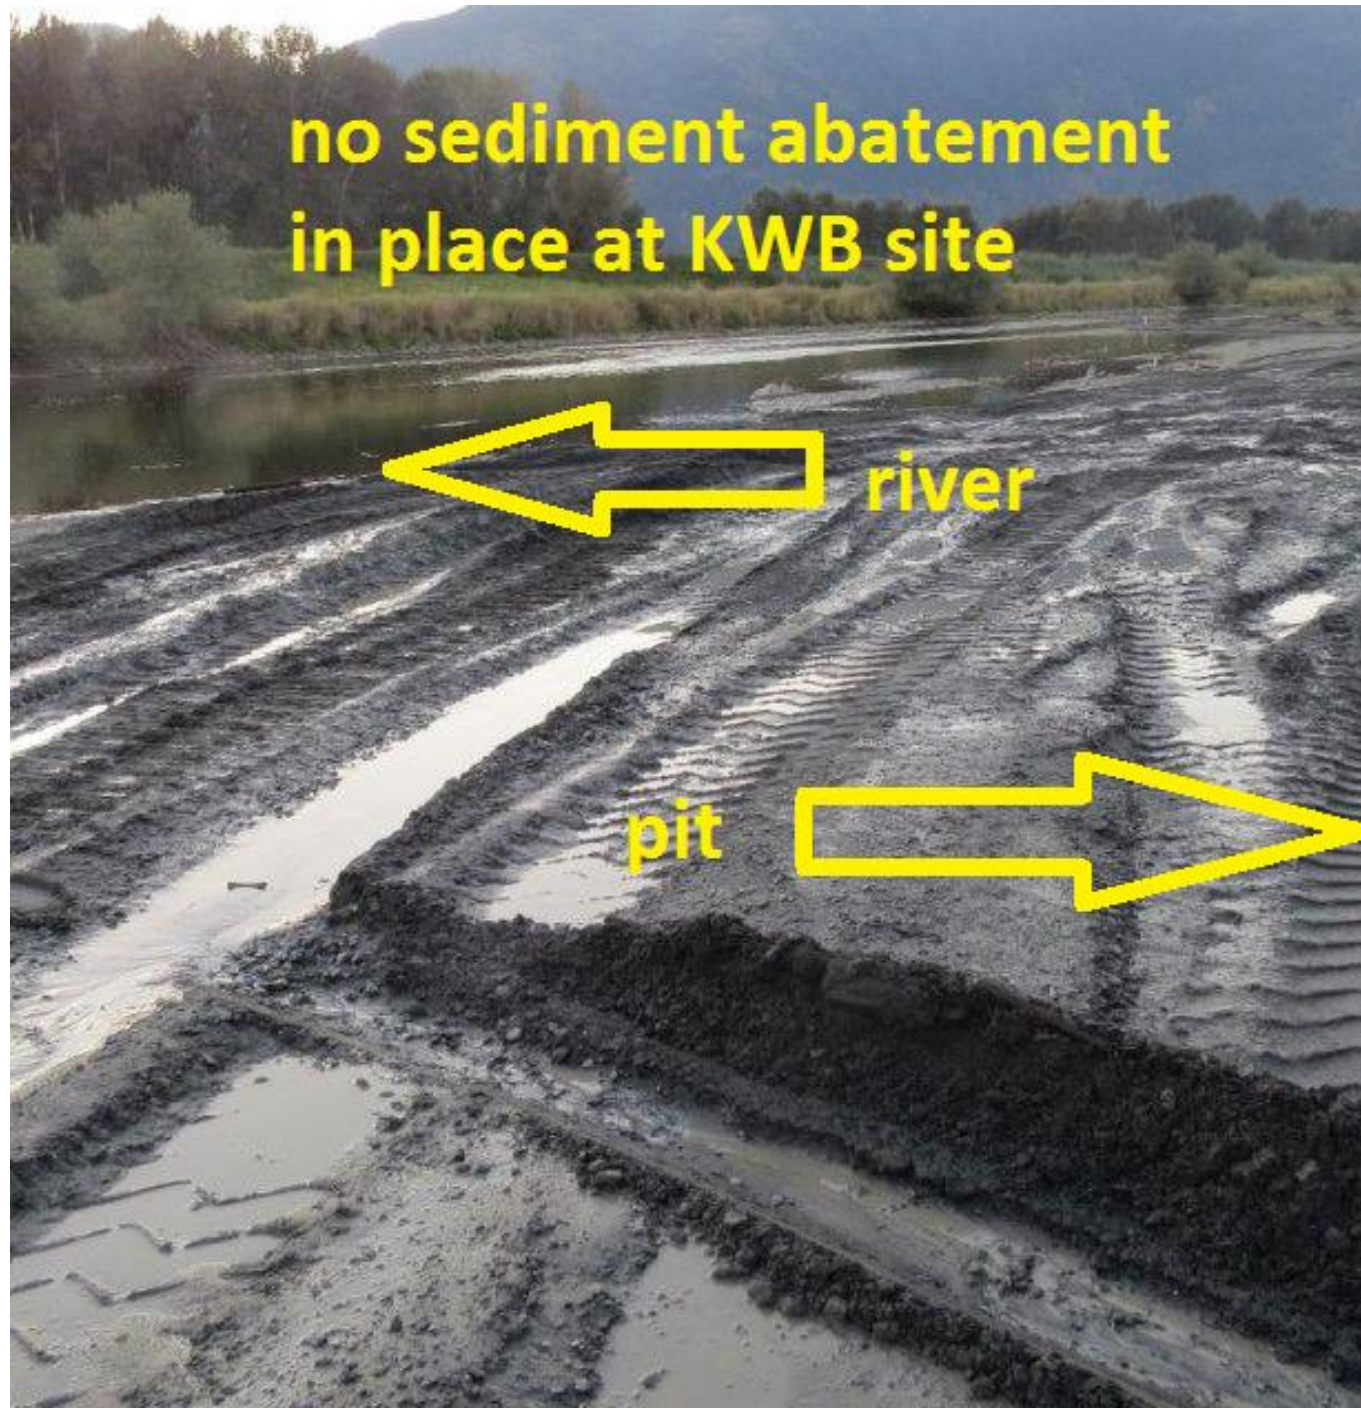
**no sediment abatement  
in place at KWB site**

# Fines used to construct a berm at the KWB site adjacent to a high-flow pump station

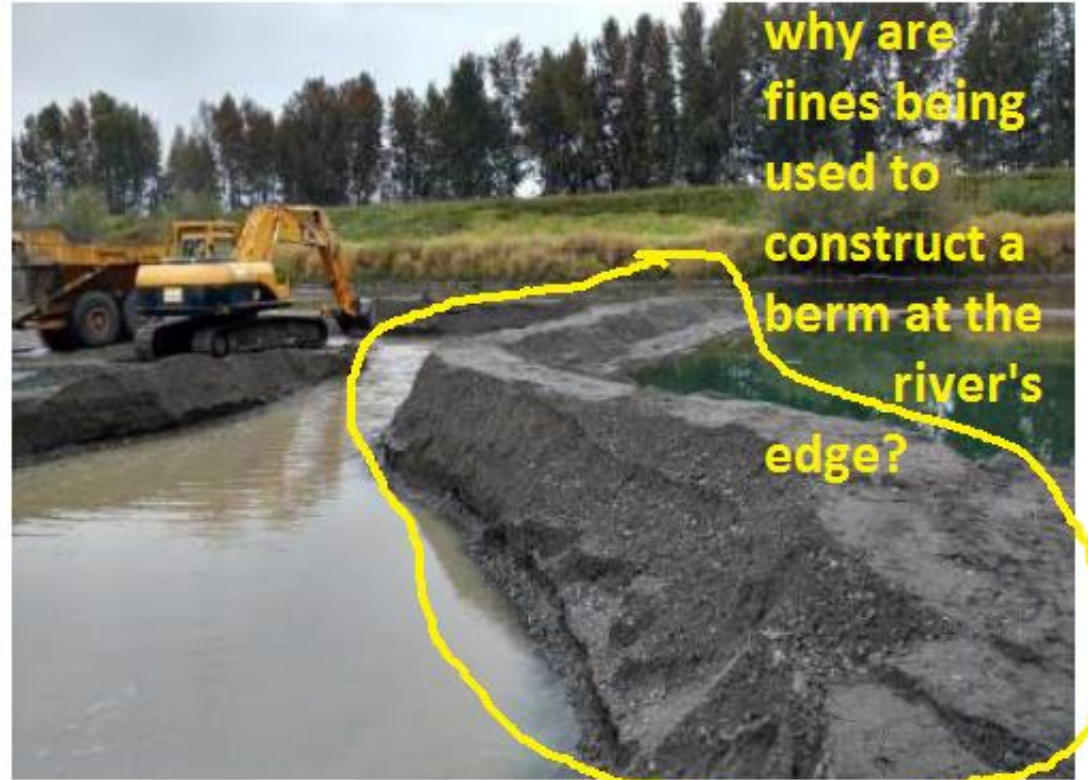
**KW8: Berm constructed at upstream end and along the river to continue excavation after heavy rain. September 23, 2016.**

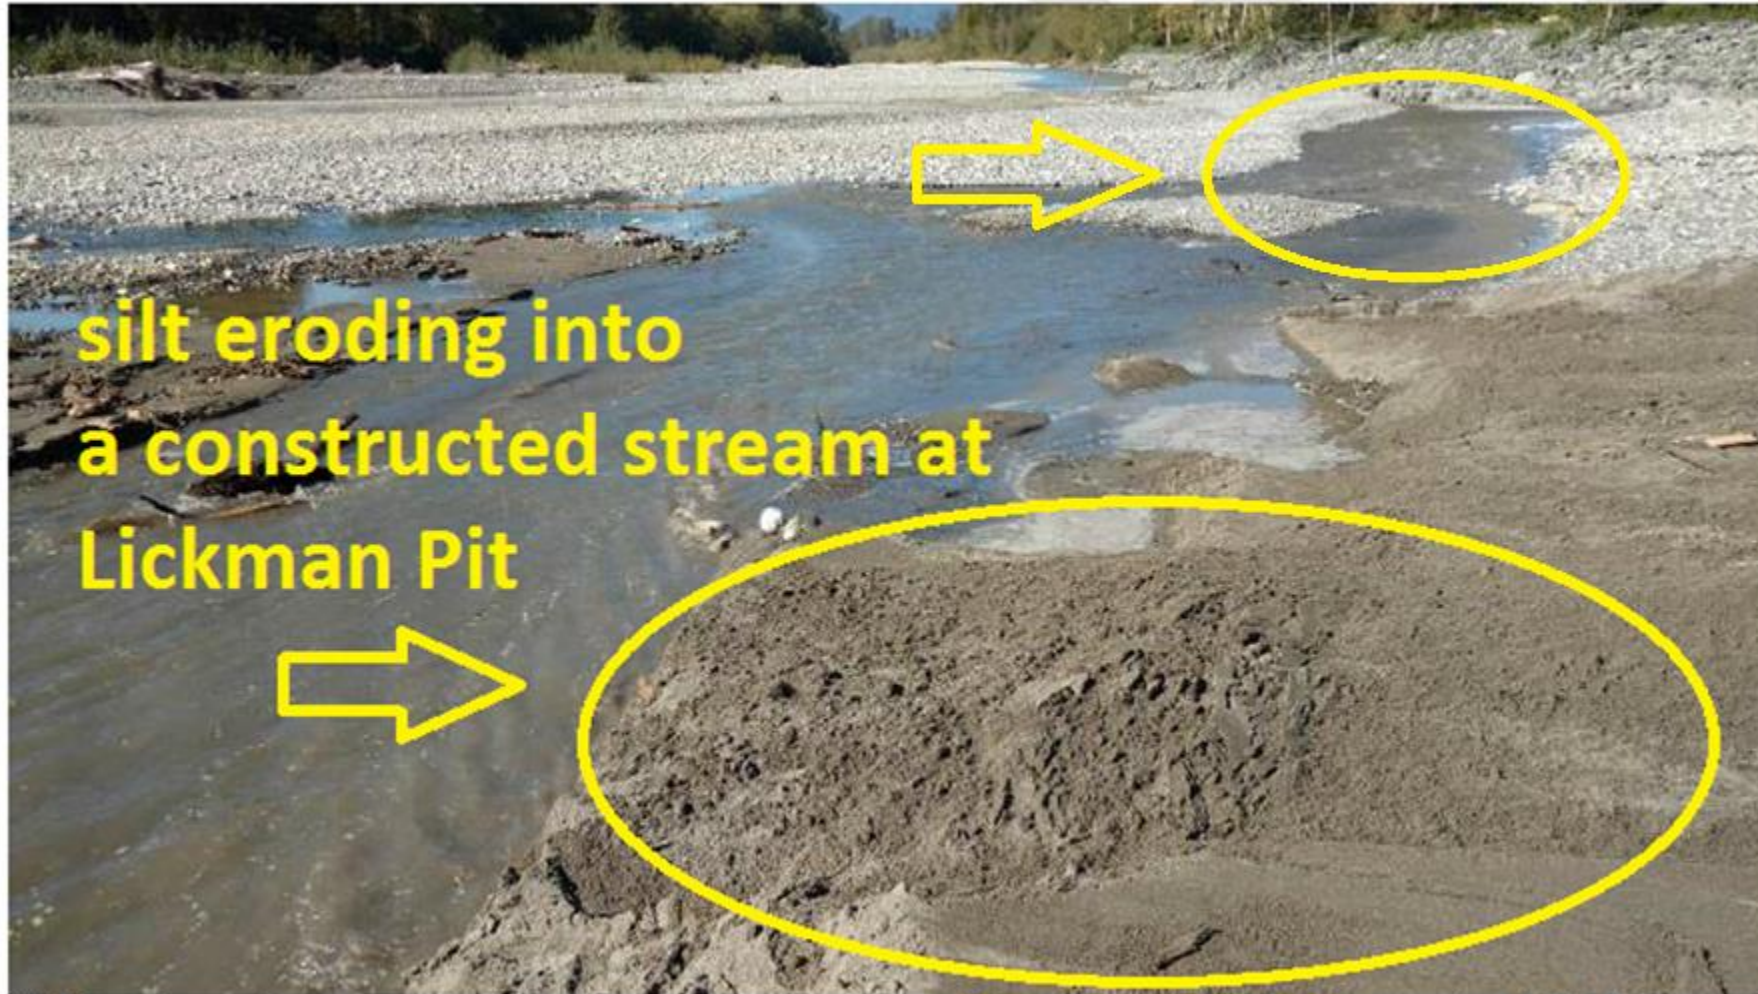
# Lickman Pit constructed-stream and silt erosion— from Nova Pacific (2016) (Dec)

**silt eroding into  
a constructed stream at  
Lickman Pit**

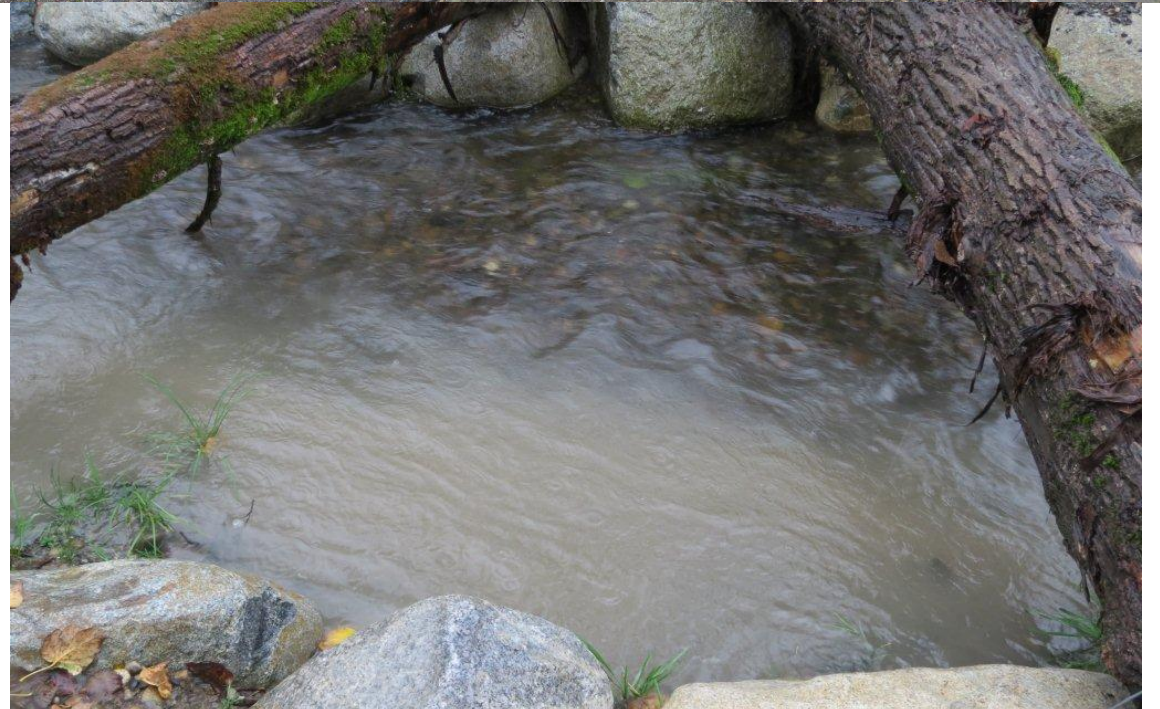
Wilson Road pit—  
how is this  
acceptable?

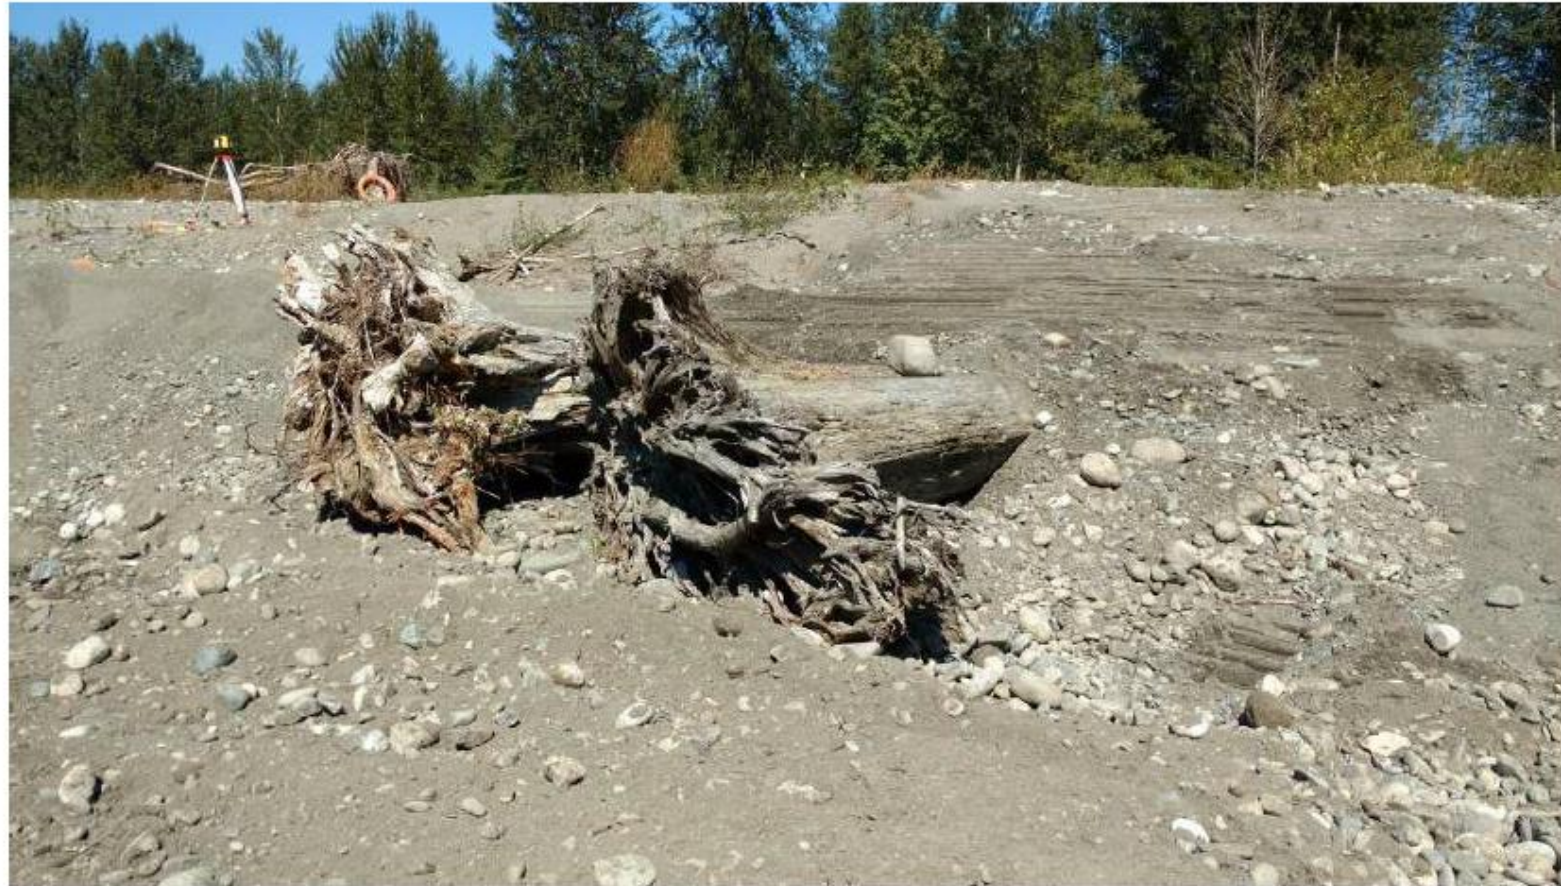
G1: LWD #G2016-1 – two pieces of LWD placed in scalped pit along the river side.

How realistic is it that such habitat structures will survive the first freshet?

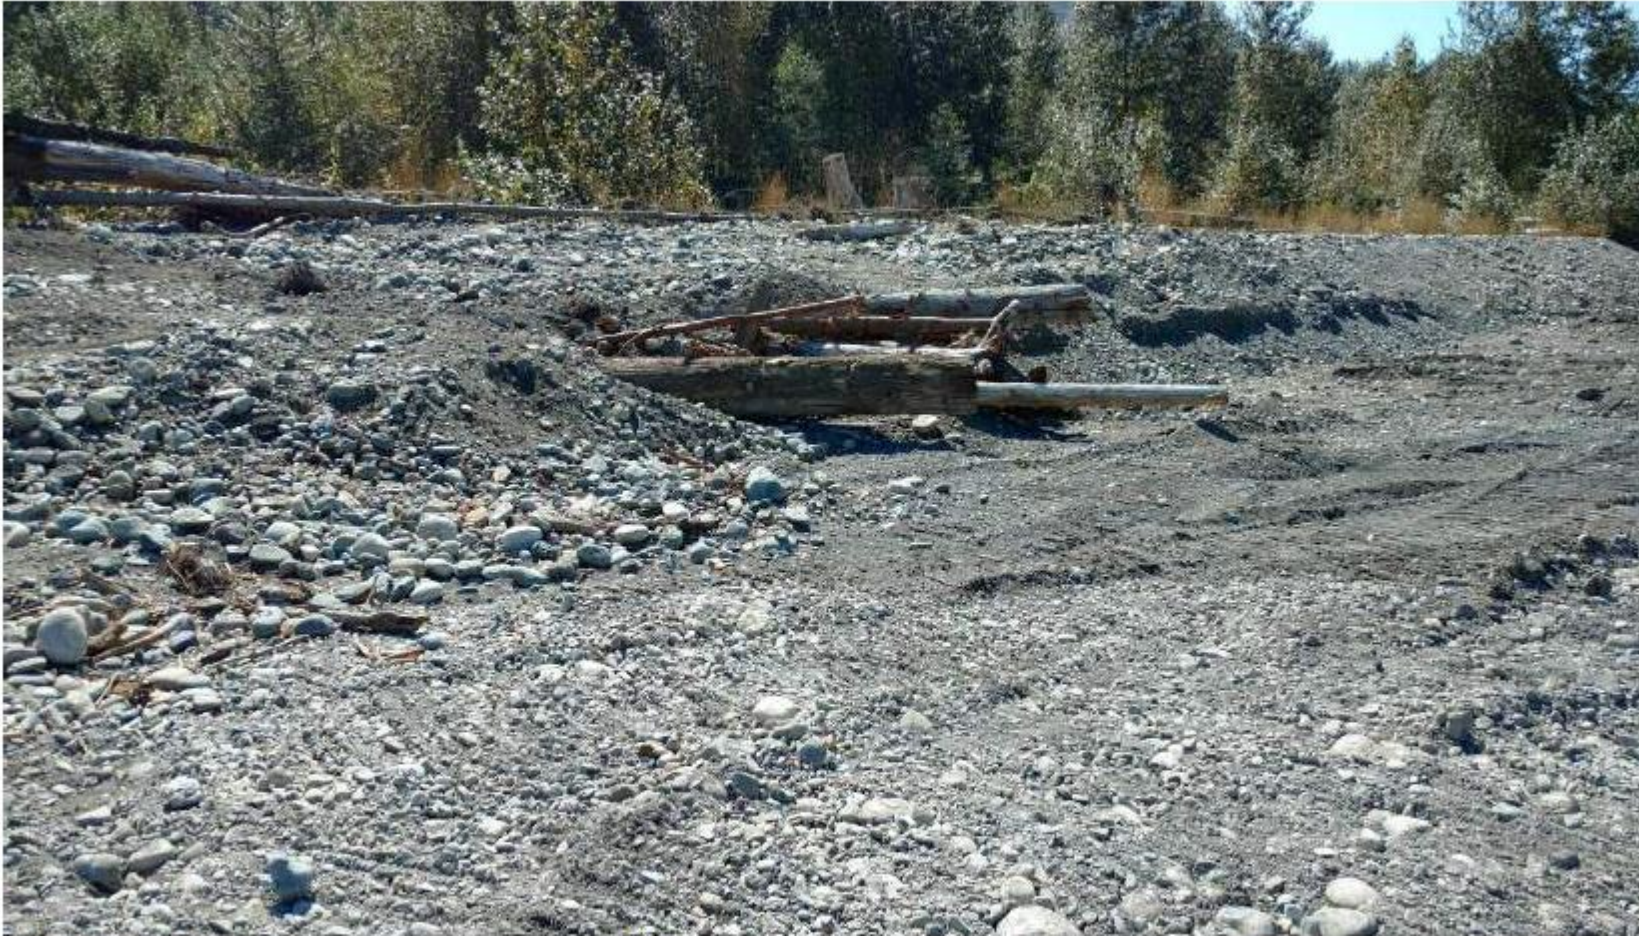
**G2: LWD #G2016-2 – several pieces of LWD placed in scalded pit along the bank side. Note a platform of boulders created upstream of LWD complex to enhance fish habitat.**

How realistic is it that such habitat structures will survive the first freshet?

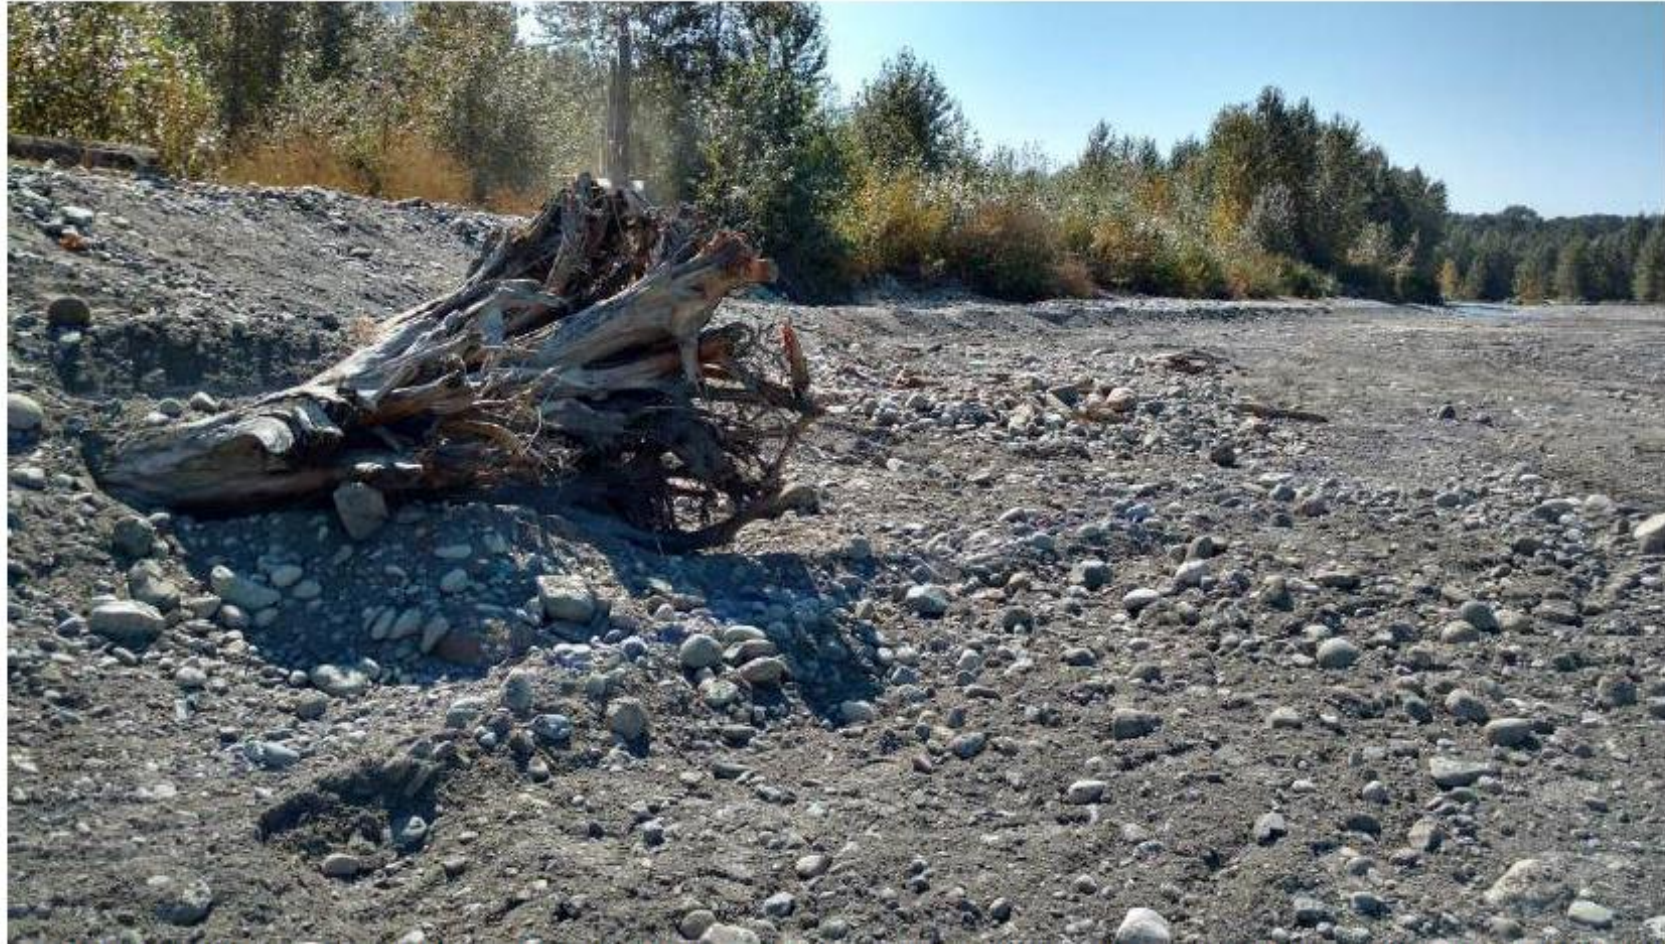
**G3: LWD #G2016-3 – two pieces of LWD placed in scalped pit along the bank side. Note a platform of boulders created downstream of LWD complex to enhance fish habitat.**

# How realistic is it that such habitat structures will survive the first freshet?
