2016 Vedder River Gravel Removal Issue—  
November 2017 Agency-Public Review

Stewardship Meeting with Agencies

November 27, 2017

THE MANAGEMENT OF SEDIMENT REMOVALS TO LONG TERM AVERAGE IS NOT DEFENSIBLE BECAUSE THE SEDIMENT VOLUMES HAVE BEEN DECLINING SINCE 2006 (KWL 2006) AND THE RIVER IS NOW ENTERING A STATE OF DEEP DEGRADATION DUE TO HISTORIC OVER-EXTRACTION AND LOW NATURAL INPUTS

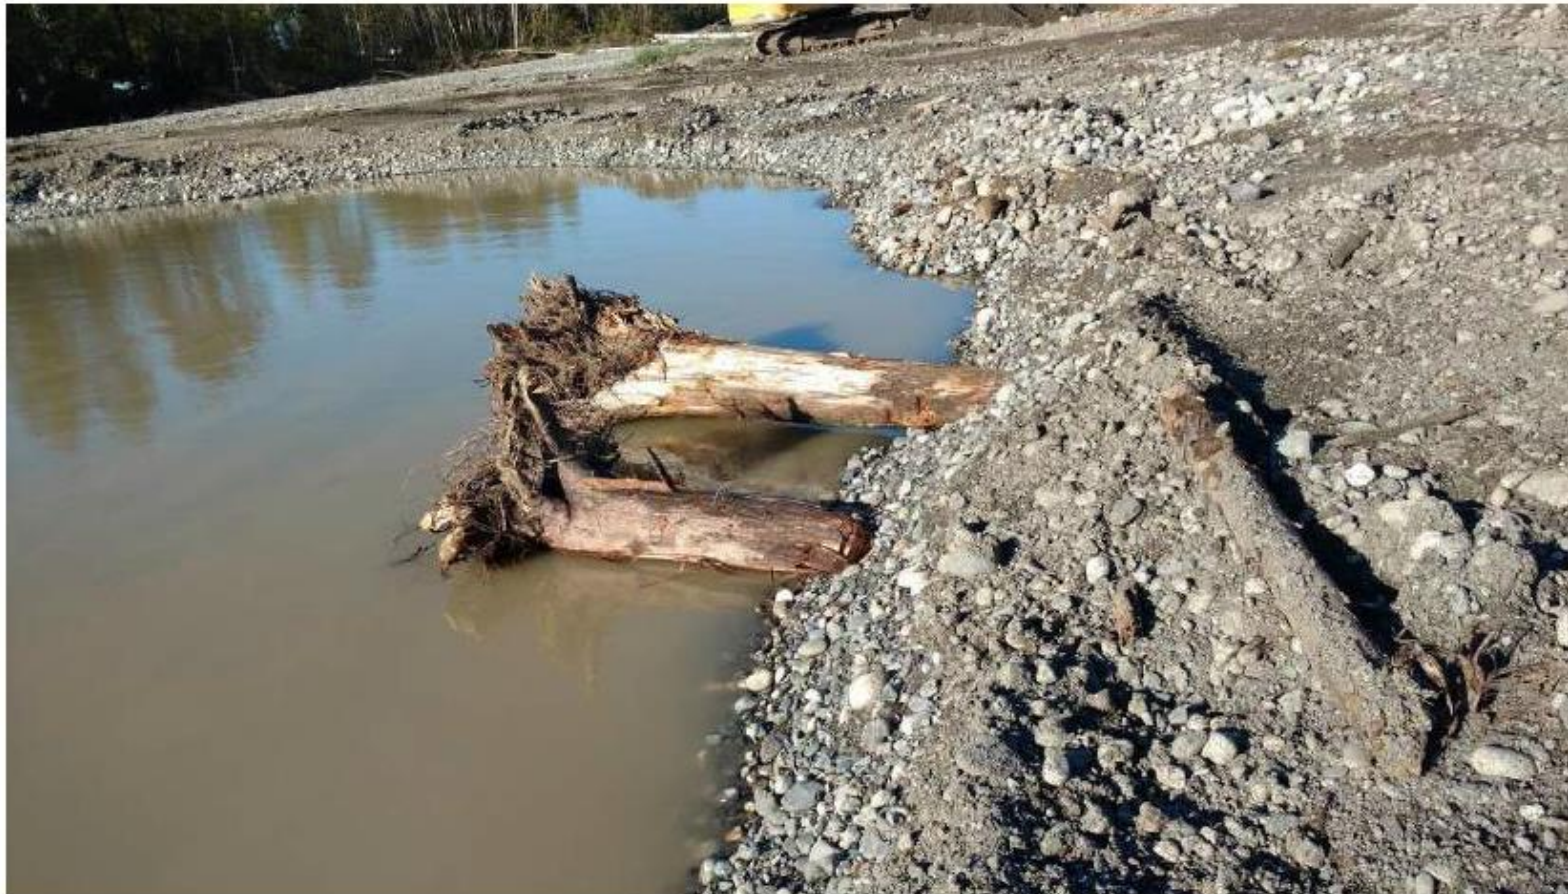
L1: LWD #L2016-1 –LWD structure placed along the bank side of the pit.

How realistic is it that such habitat structures will survive the first freshet?

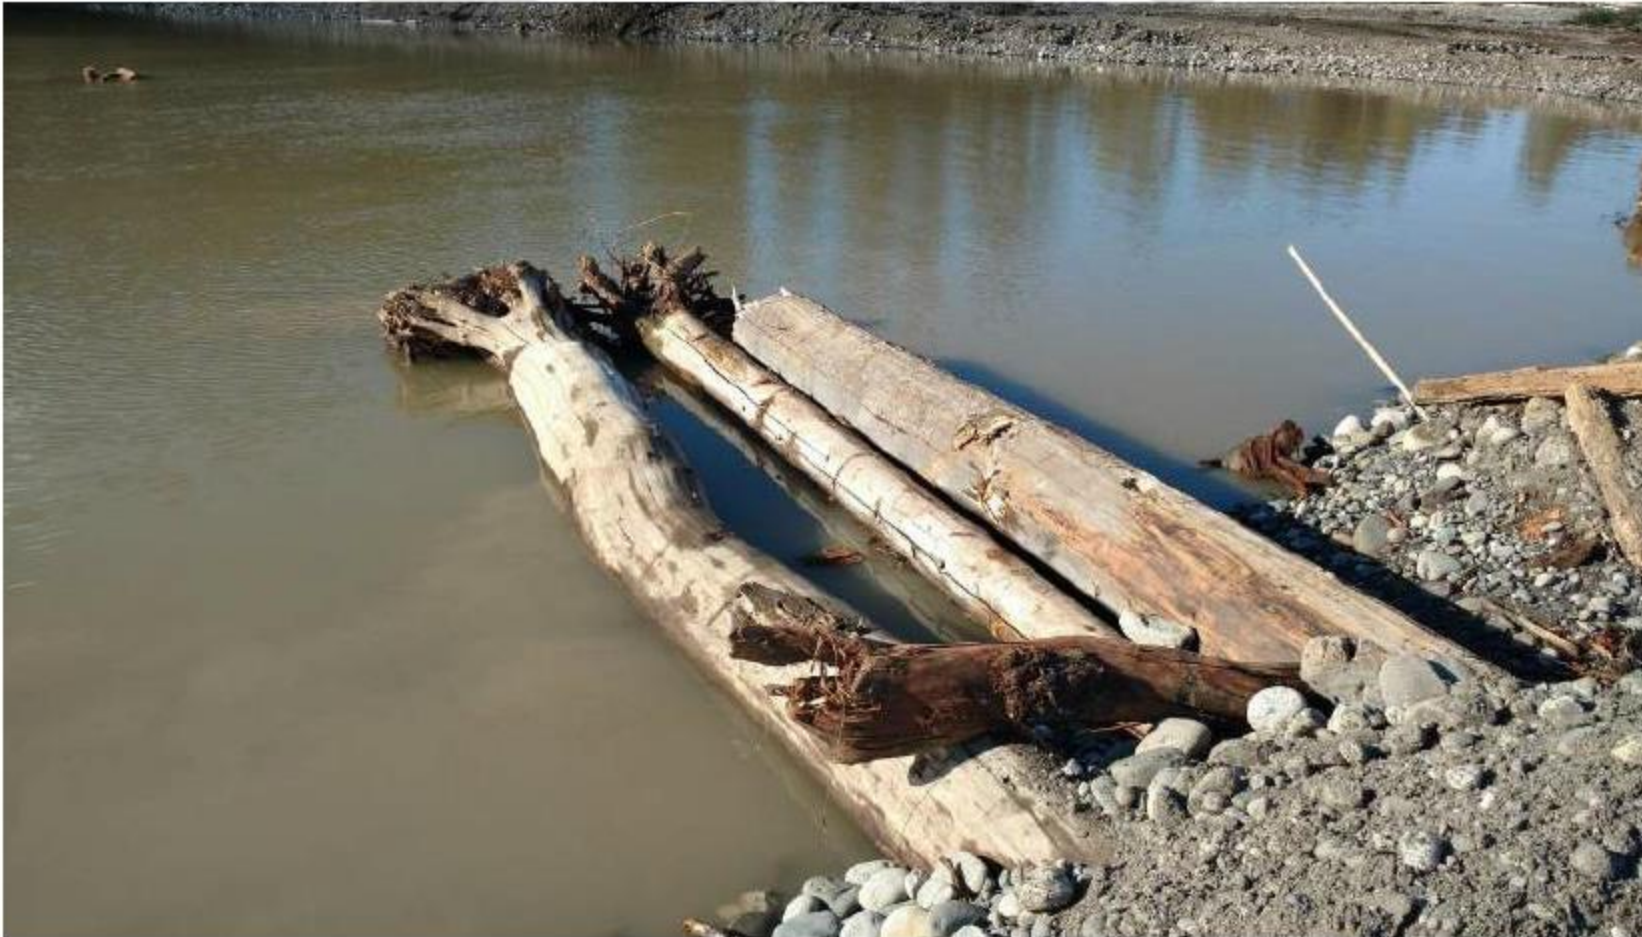
L2: LWD #L2016-2 –LWD structure placed along the bank side of the pit upstream of LWD #L2016-1.

How realistic is it that such habitat structures will survive the first freshet?

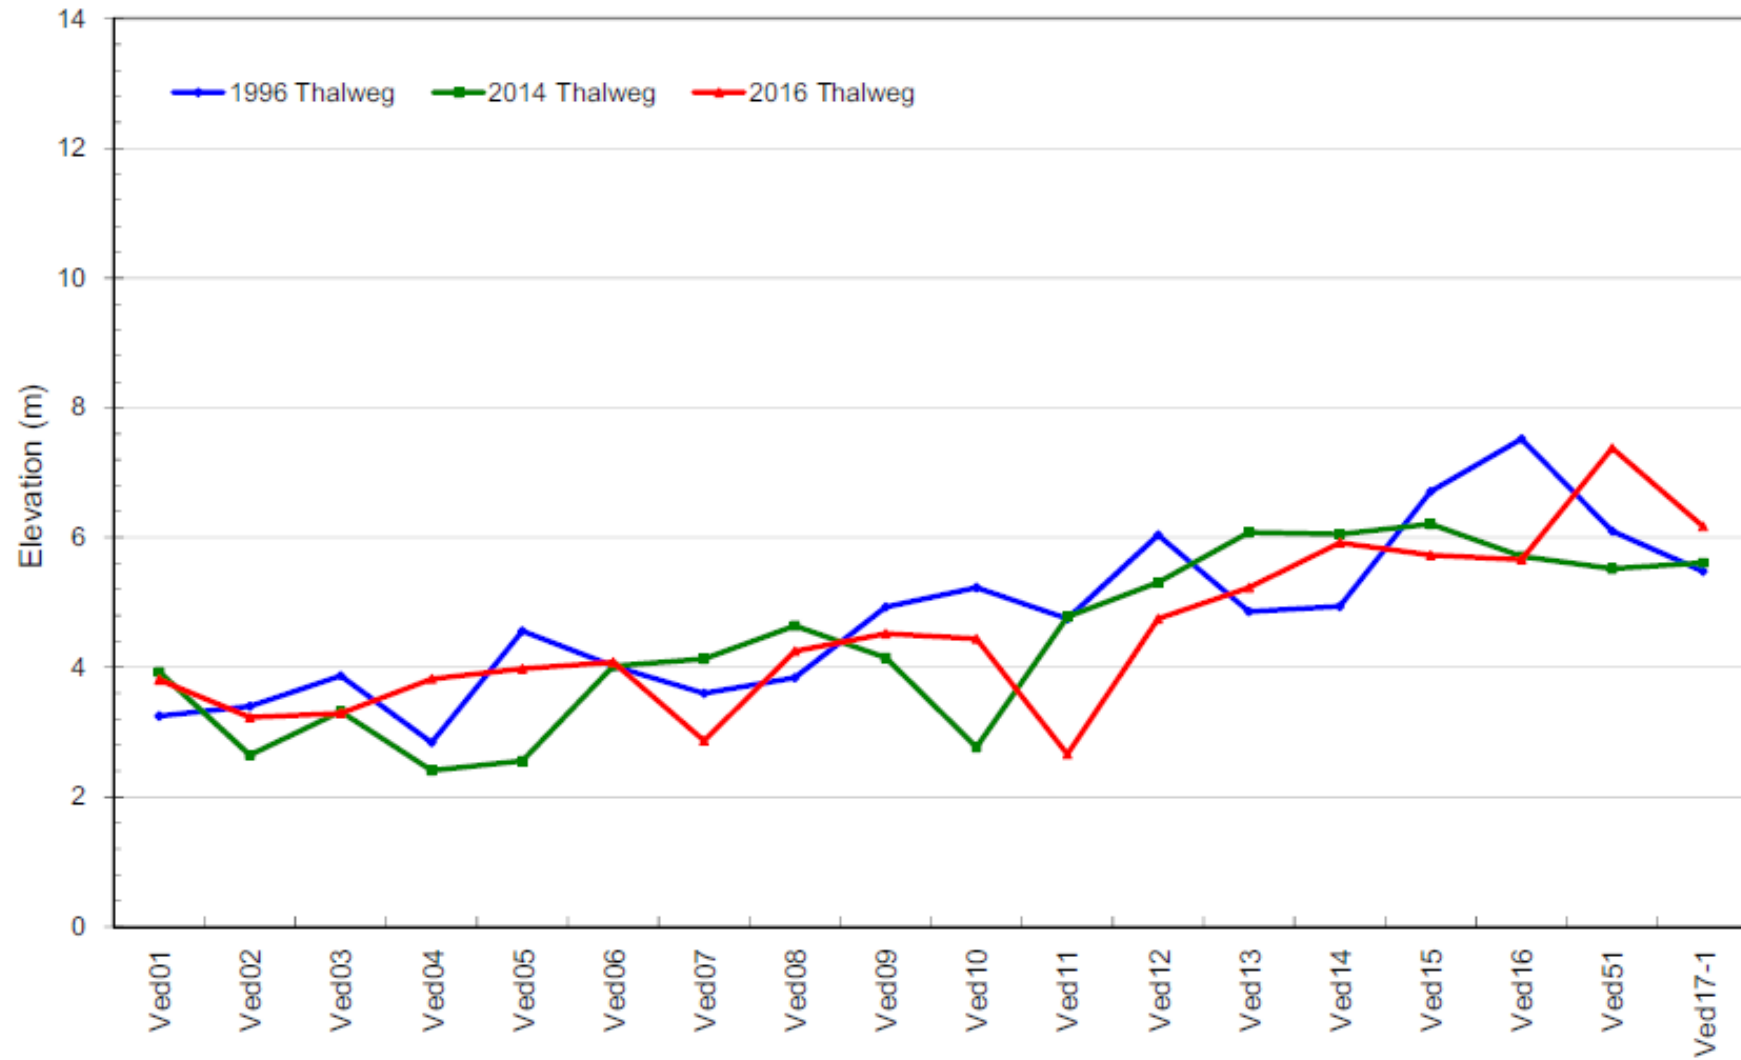
# KWL (2016) thalweg elevations for the Vedder River XS1 to XS17-1—note the 2016 deepening compared to 1996
