Vedder River

Hydraulic Profile Update 2018

Final Report
May 2018
KWL Project No. 0607.027

CITY OF
CHILLIWACK

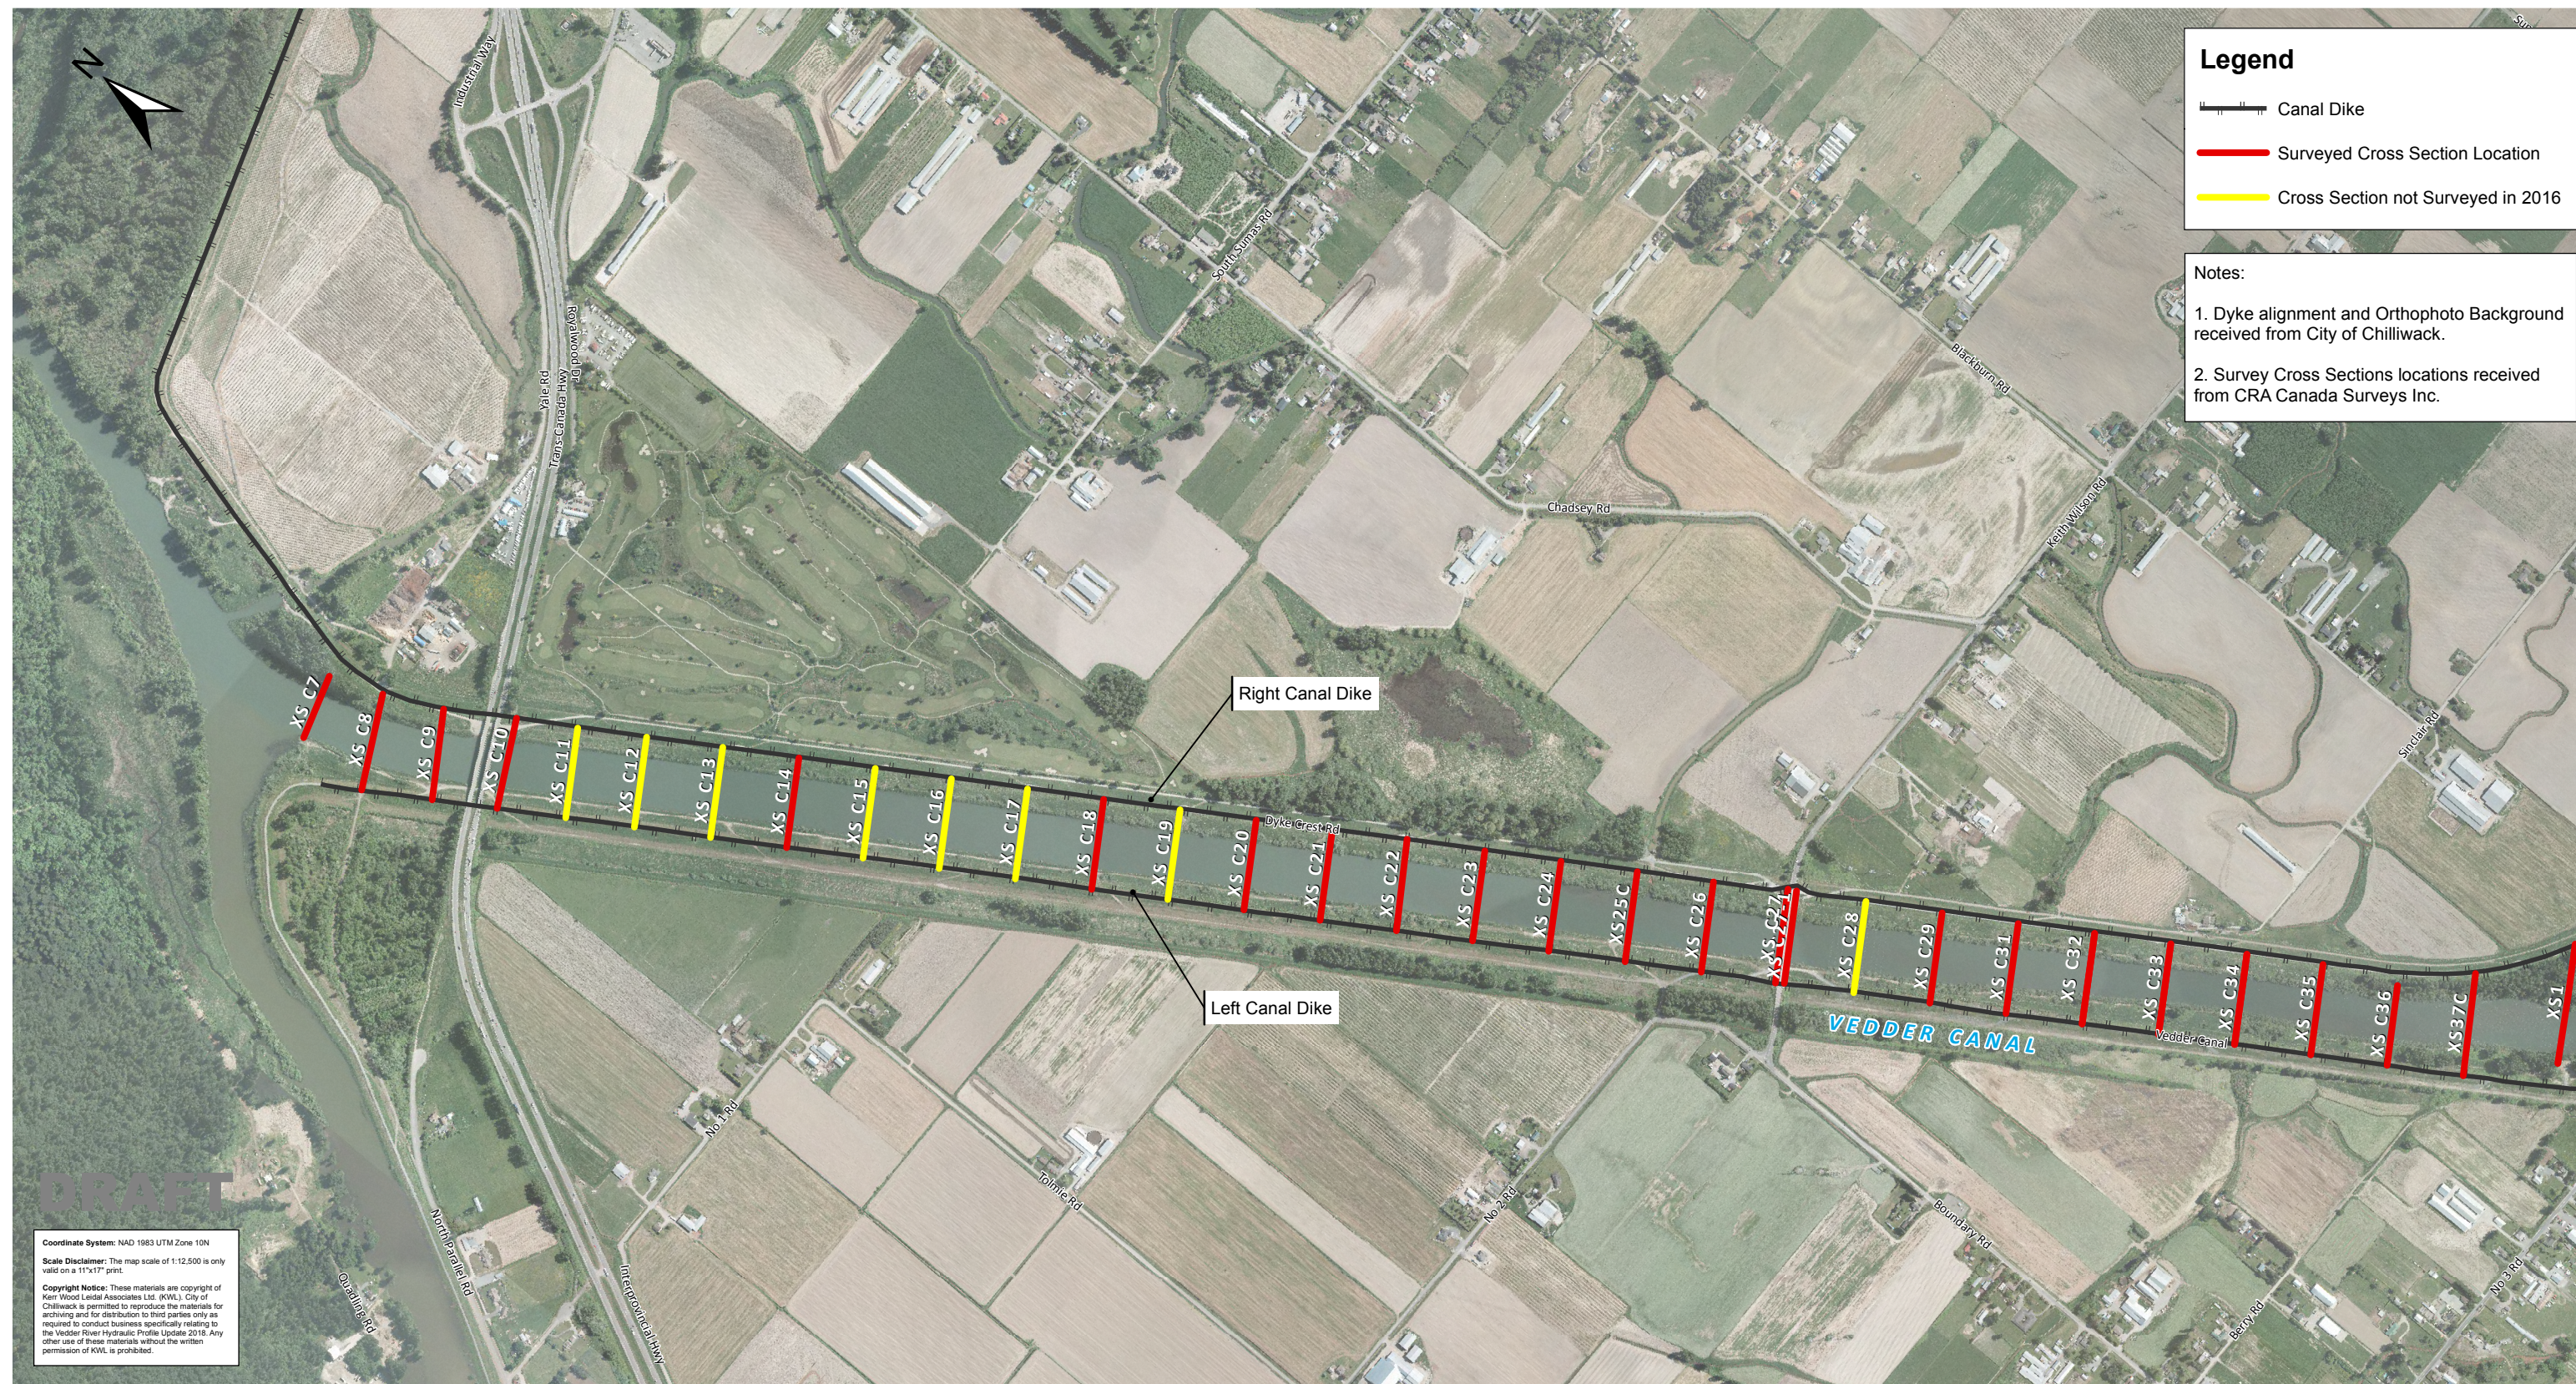
Vedder River Cross Section Locations - Vedder Canal

The 2018 channel geometry survey was conducted by CRA Canada Survey Inc. from January 15 to March 5. The river channel was surveyed from bank to bank with additional points on the top of the setback dikes where applicable. Additional cross sections XSC7, XSC8 and XSC9 were surveyed in the Vedder Canal from the Highway 1 Bridge to the mouth. Overbank areas were not surveyed and were assumed to remain the same as the 2004 overbank survey. Paired distance-elevation survey data were provided in .XLS format oriented looking downstream. Historical cross sections for 2016 and 1991/1996 were also supplied in .DWG plan format for volume calculations. Survey plans of the Vedder Canal and Vedder River are provided in Figure 1 and Figure 2.

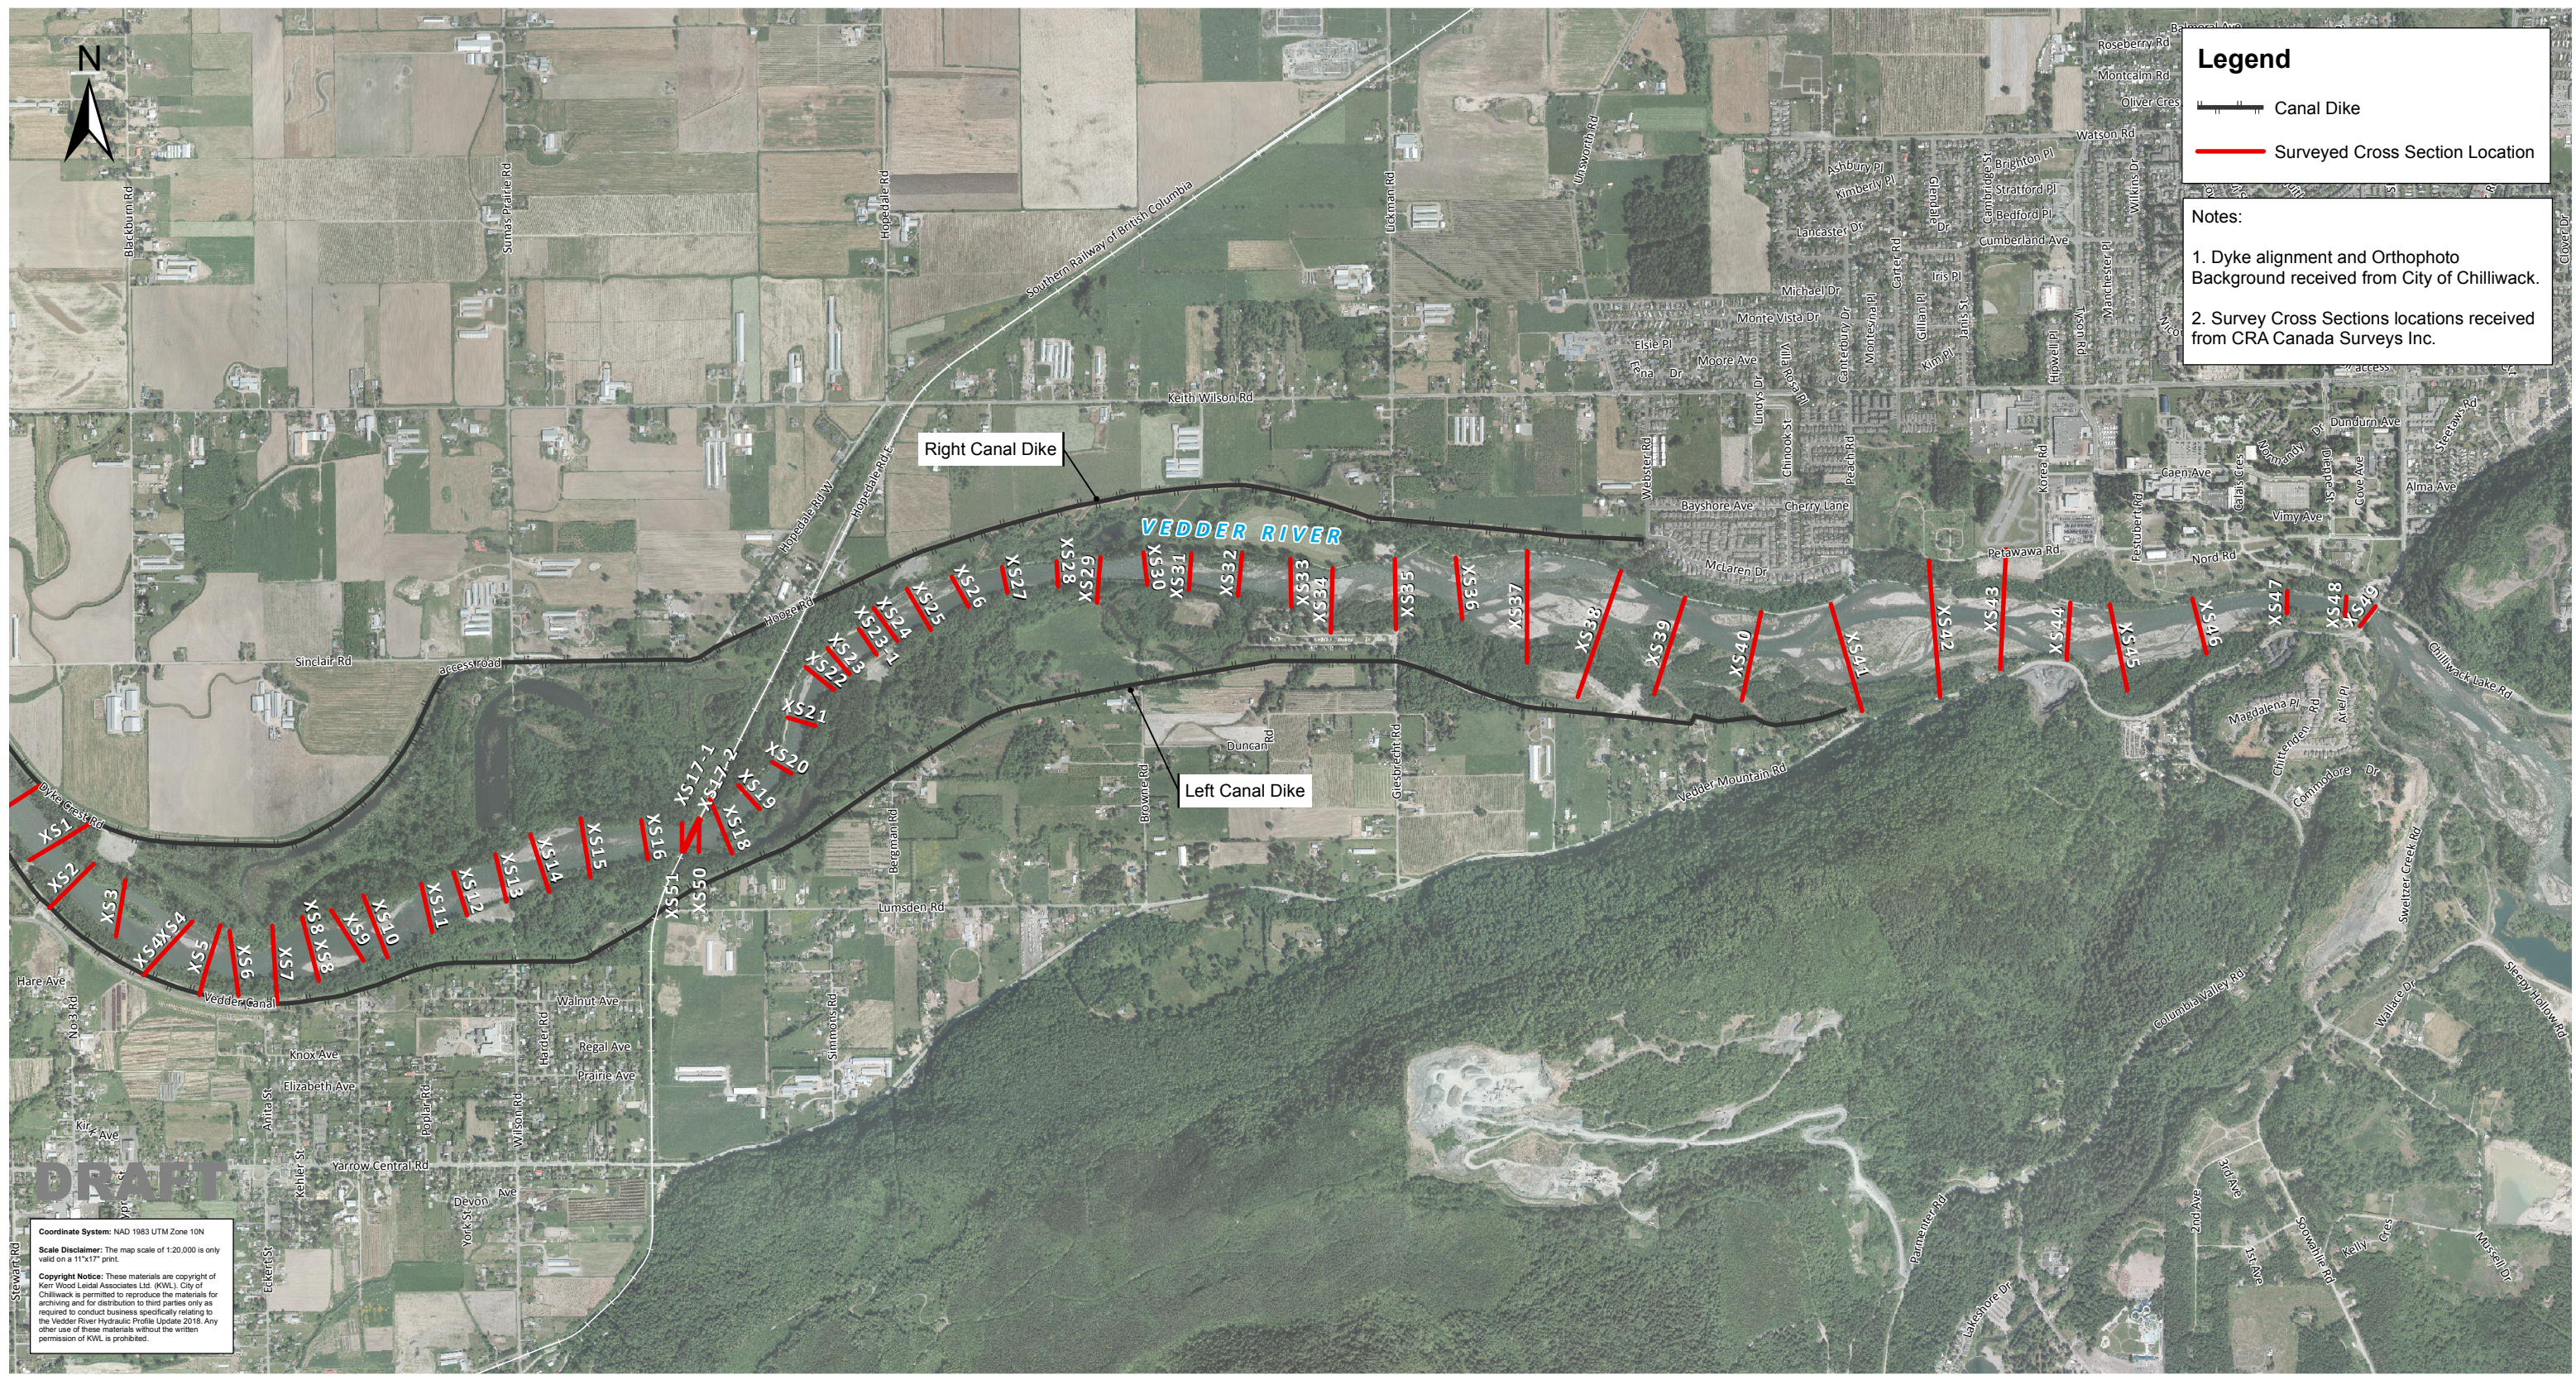
Figure 2

Vedder River Cross Section Locations - Vedder River

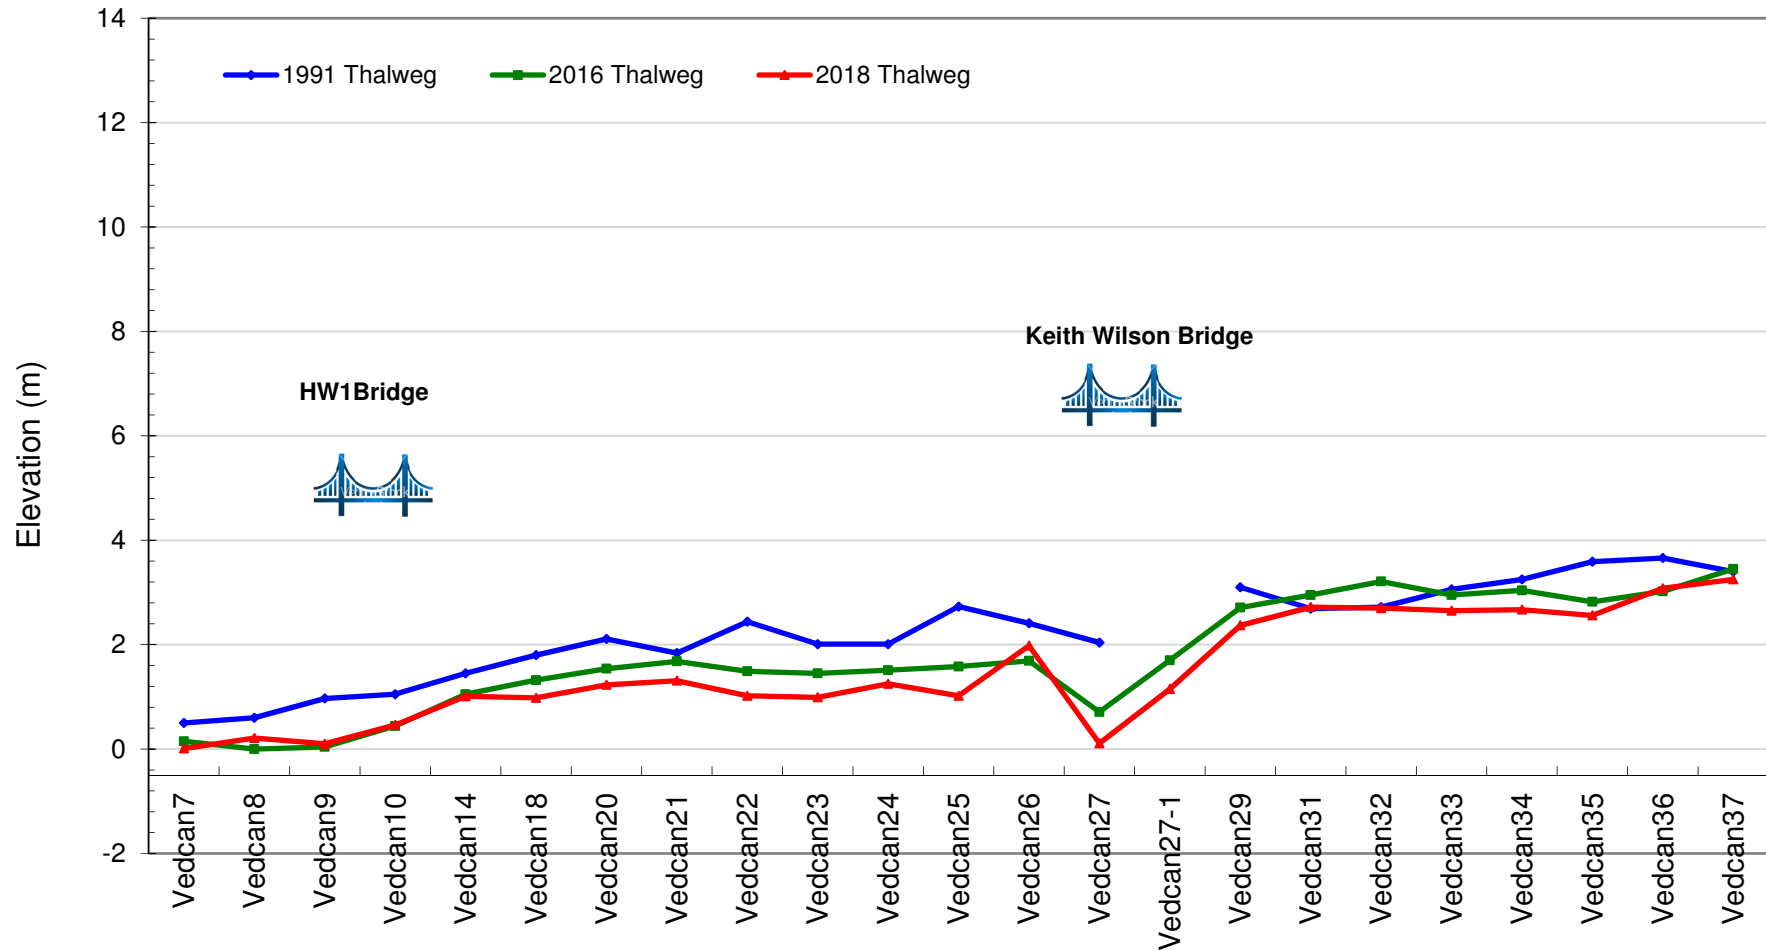
The Vedder Canal thalweg profiles for 1991, 2016 and 2018 are provided in Figure 3. Compared with 2016, the 2018 Canal thalweg profile has consistently lowered by an average of 0.3 m from XSC14 to XSC35, which accounts for 80% of the length of the Vedder Canal. Relative to 1991, considerable lowering also occurred in the Canal bed level. The majority of the thalweg dropped by 0.6 m to 1.0 m except for between XSC31 and XSC32 and at XSC37. A greatest thalweg drop, ranging from 1.7 m to 1.9 m, was found at XSC25 and XSC27.

At the downstream end of the Canal (i.e. XSC7, XSC8, XSC9), the thalweg has dropped an average of 0.6 m since 1991. Between 2016 and 2018, the thalweg profile remained at a similar level. The 2016 channel excavation site at the Keith Wilson Bar has partially infilled at the upstream end (XSC26) and not infilled at the middle section (XSC25).

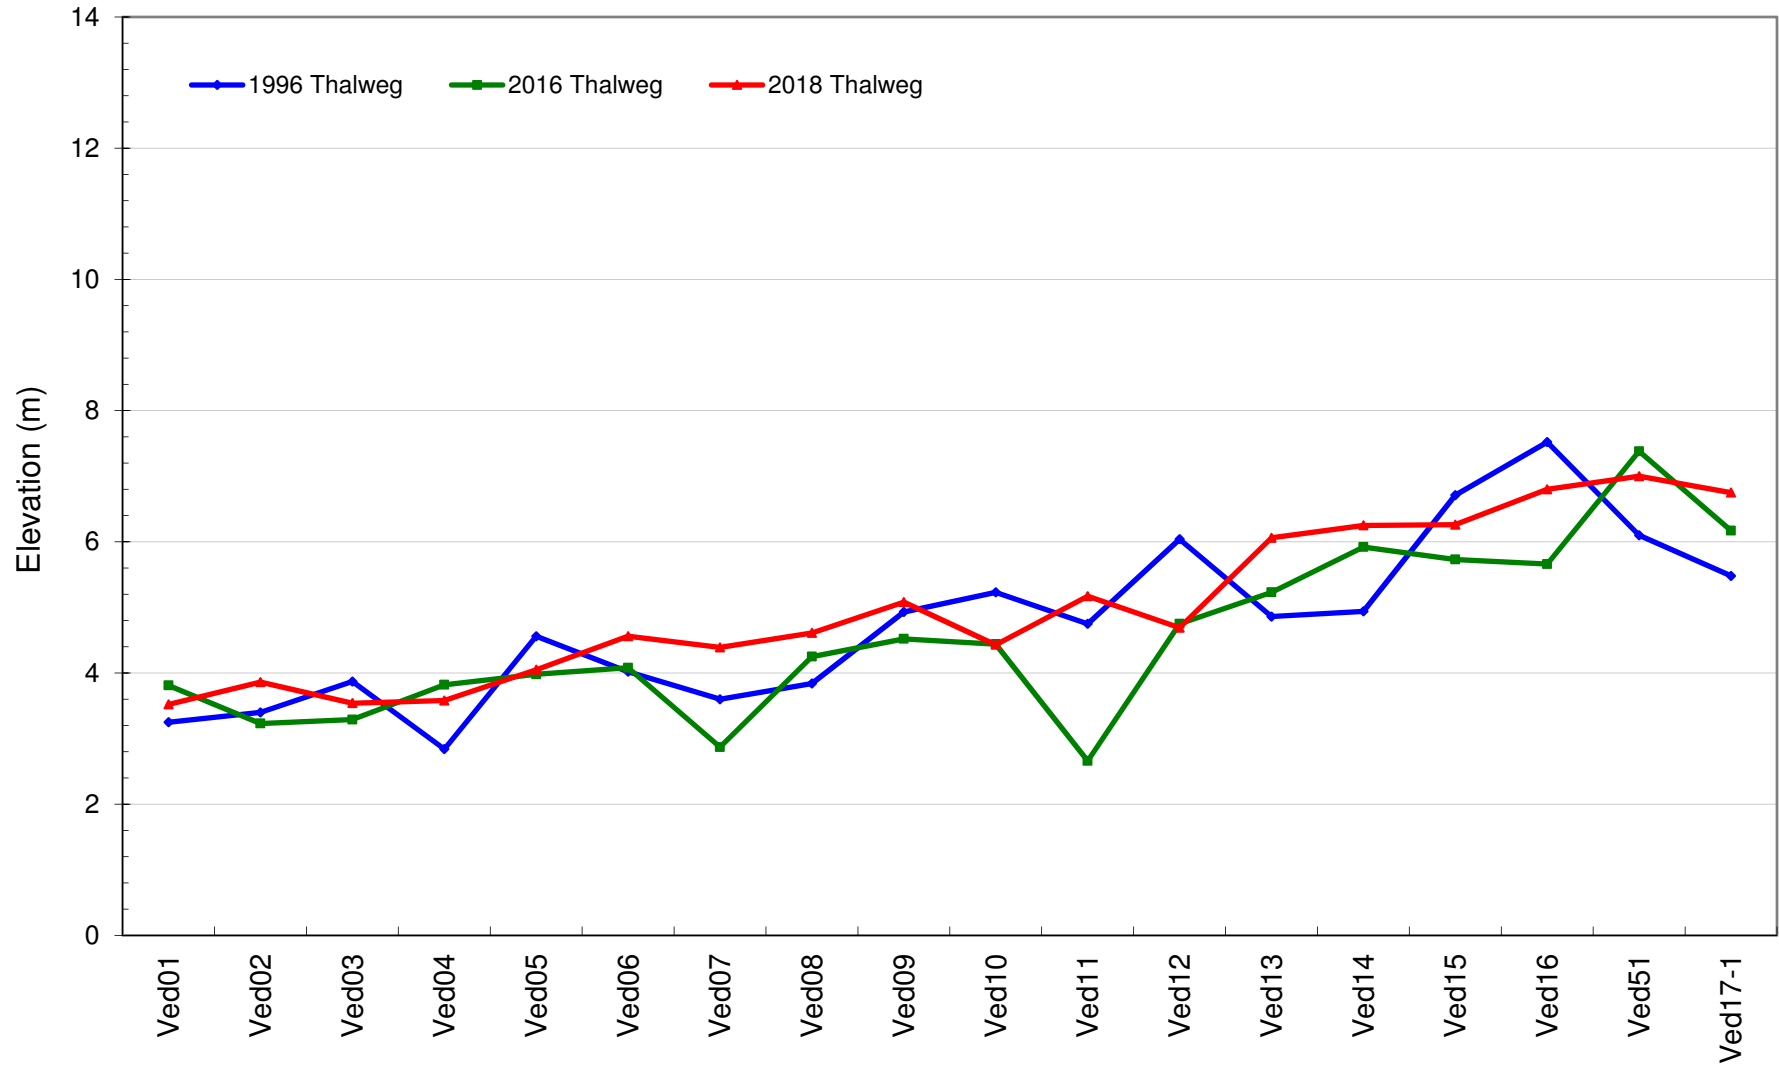
FIGURE 4

The Vedder River thalweg profiles for 1996, 2016 and 2018 are shown in Figures 4 to 6. Examination of the profiles shows greatest degradation at XS12, XS33 and XS43, where the channel bed lowered by 1.4 m, 1.1 m and 1.3 m, respectively, since 1996. The greatest thalweg increase was found in the upper reach from XS 41 to XS42, with the increase averaging 2.7 m.

Compared with the 2016 condition, the Vedder River mean thalweg profile elevation increased by 0.5 m, 0.3 m and 0.2 m for the lower, middle and upper reach, respectively. The greatest increase occurred at XS7 and XS11 of 1.5 m and 2.5 m respectively.

The river thalweg switched sides at XS32 due to redistribution of channel material, and at XS24 and XS14 resulting from the 2016 gravel excavation at the Bergman Bar and Yarrow Bar. The 2016 channel excavation sites at XS23 (Bergman Bar) and XS41 (Giesbrecht Bar) have partially infilled. XS19 (Railway Bar) has fully infilled close to pre-excavation levels.

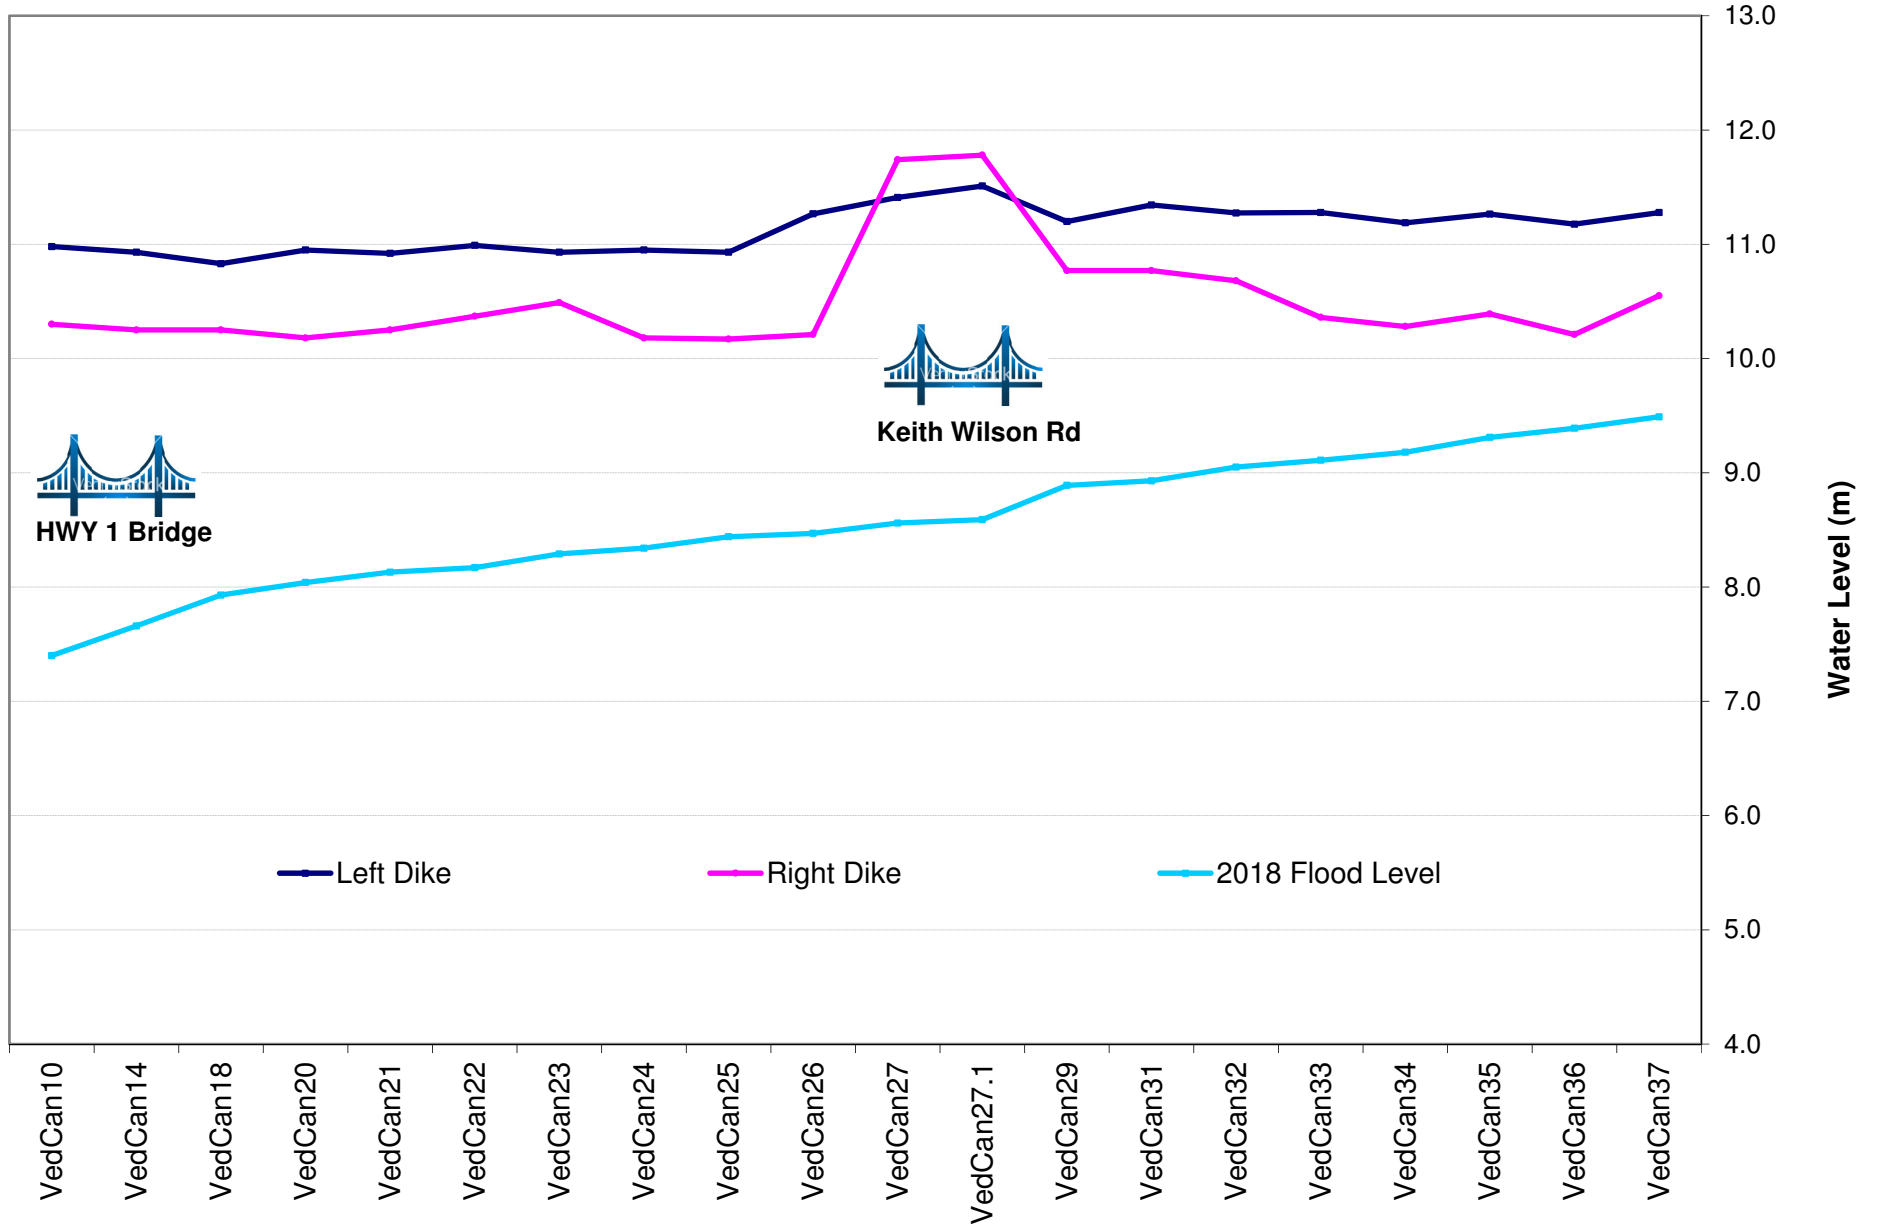
FIGURE 7

The 2018 flood profile was calculated and compared to the setback dike crest elevations. Sub-critical flow conditions were assumed in the HEC-RAS model, which provides conservative results for the flood level. The resultant left and right dike freeboards are as listed in Table 4 for the Vedder Canal and in Table 5 for the Vedder River. The freeboard on the right bank (Rotary Trail) from XS40 to XS49 is also included.

In the Vedder Canal, the dike freeboard exceeds 0.75 m on both sides. The Canal dike was designed for the Fraser River freshet flood water levels, which exceed the water levels during the Vedder River winter design flood event of 1,470 m³/s. In the Vedder River the setback dike freeboard exceeds 0.75 m except at Vedder River XS8 to XS13 on the right (north) side. The minimum freeboard is determined to be 0.52 m at XS9. The computed flood profiles, in comparison to the dike crest elevations for the Vedder Canal and Vedder River, are shown in Figures 7 to and 8. Flow leaving the right bank at XS48 will re-join the river at a lower location upstream of the critical reach.

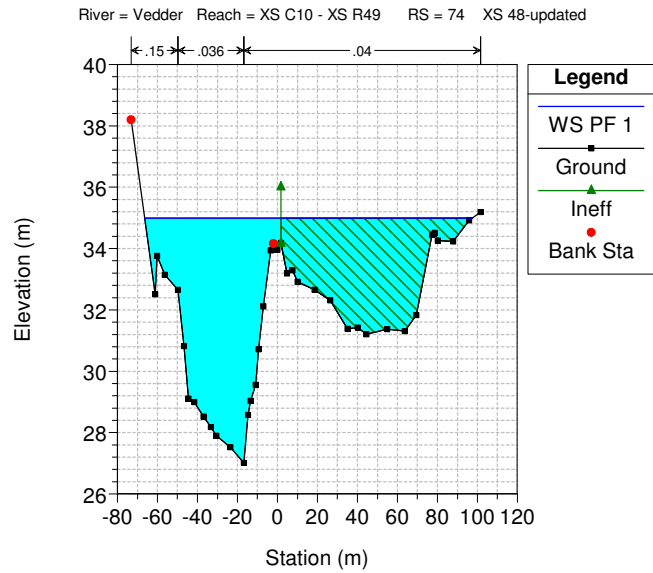
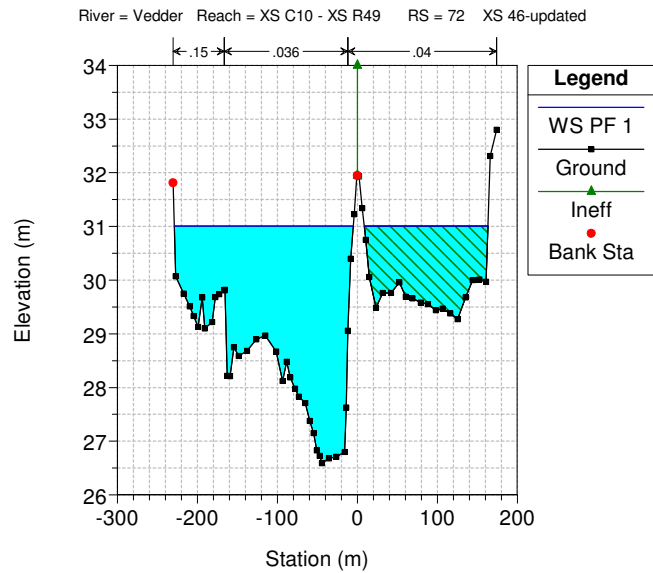
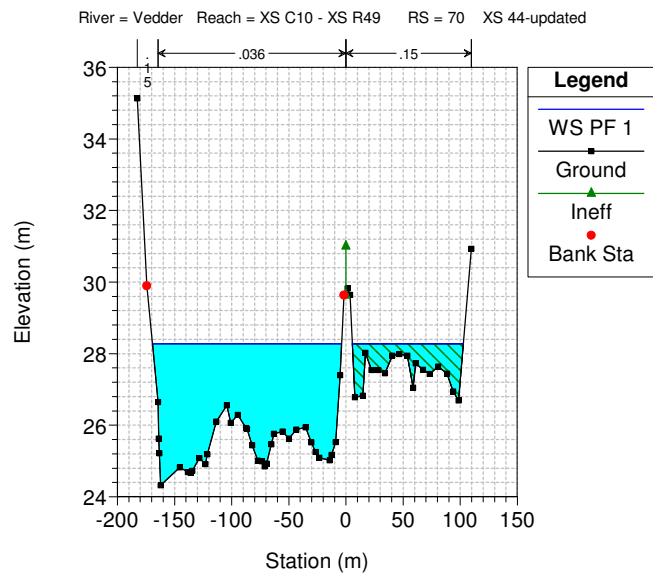
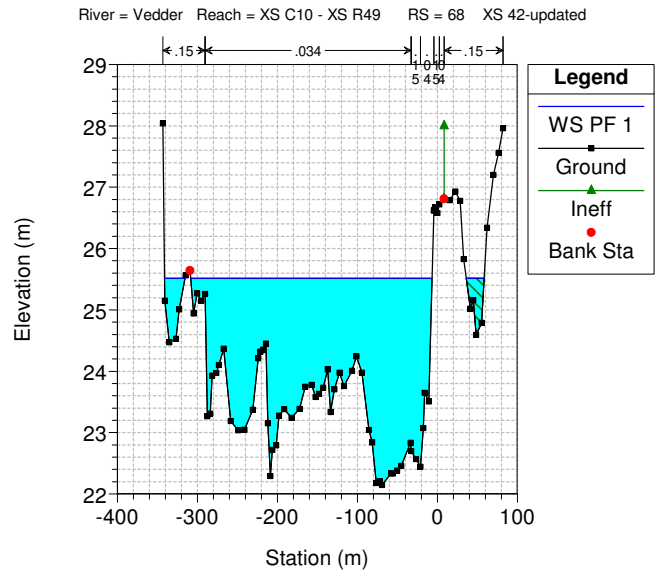
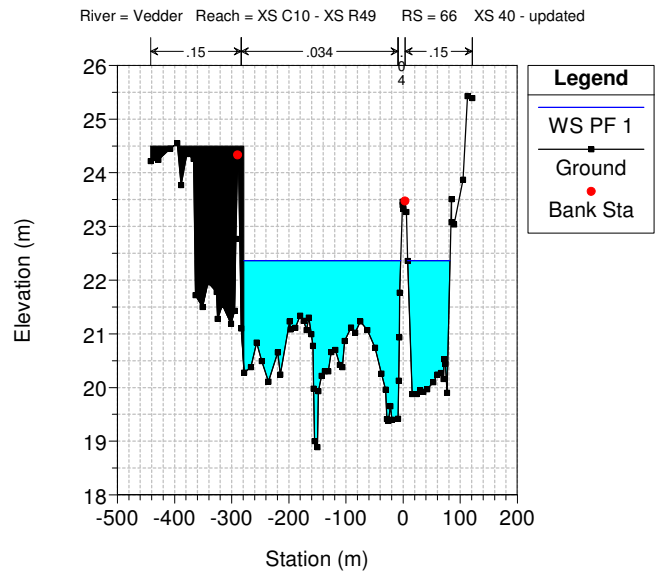
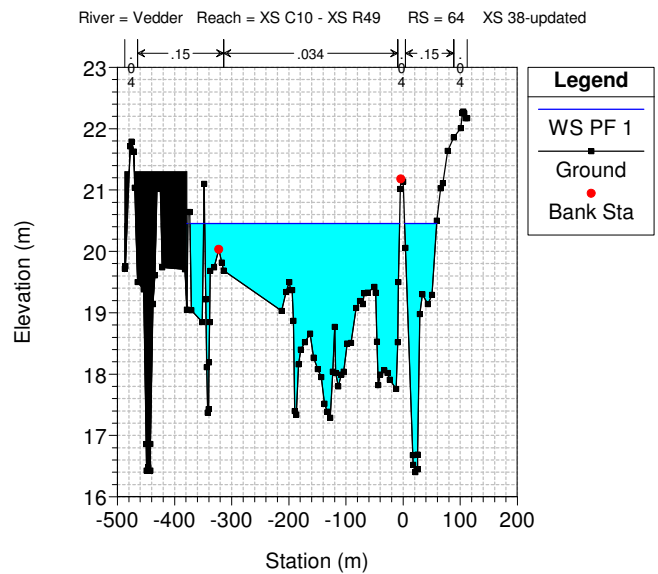
2018 HEC-RAS Water Surface Elevations

The 2018 HEC-RAS cross section plots, showing the updated water surface elevations, are provided in Appendix C.
