Proposed 2022 Vedder River Sediment Removal Project

Nova Pacific Environmental

5/29/2022

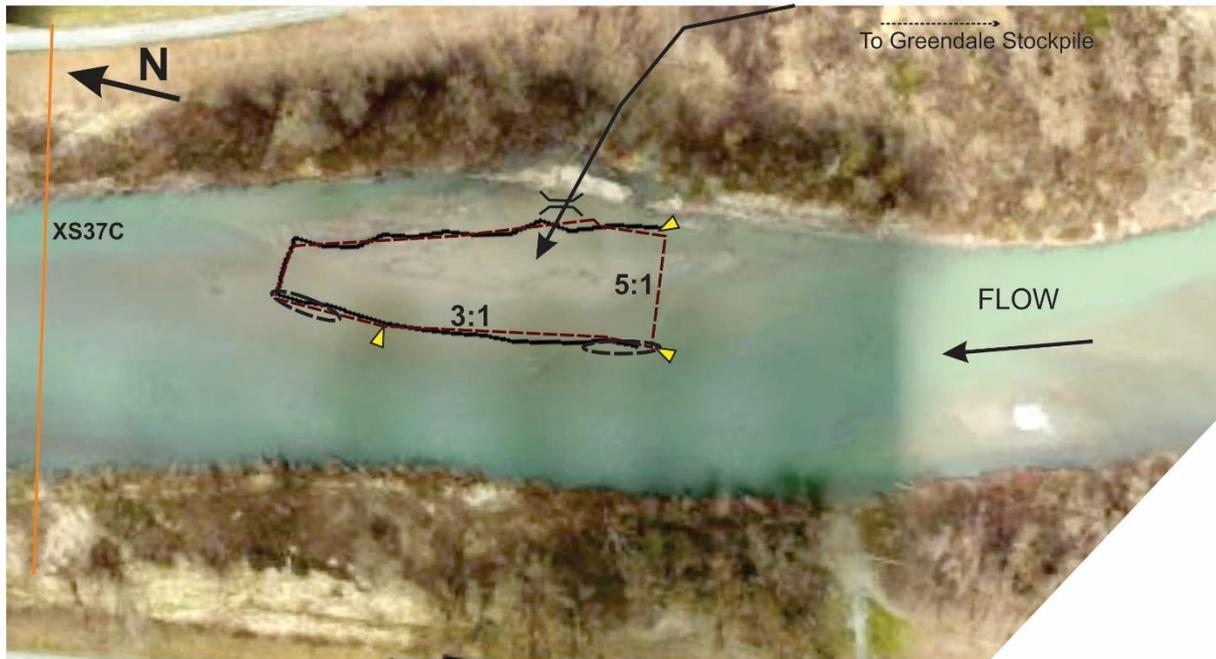
2022 Proposed Excavations: Salad Bar (22-C37R)

Figure 6: Salad Bar A excavation.

There is little enhancement opportunity at this bar, but some LWD will be keyed in as appropriate. The existing habitat channel along the right bank will be maintained and culverts will be utilized to cross the channel at the upstream end of the bar. The existing access road extends right to the bank so no damage to riparian vegetation will occur.
