Review of 2024 Vedder River Gravel Removal Plan

April 18, 2024
Final Report, Rev. 0

**BC Ministry of Environment and Climate Change
Strategy**
Environmental Protection Division,
Victoria, BC

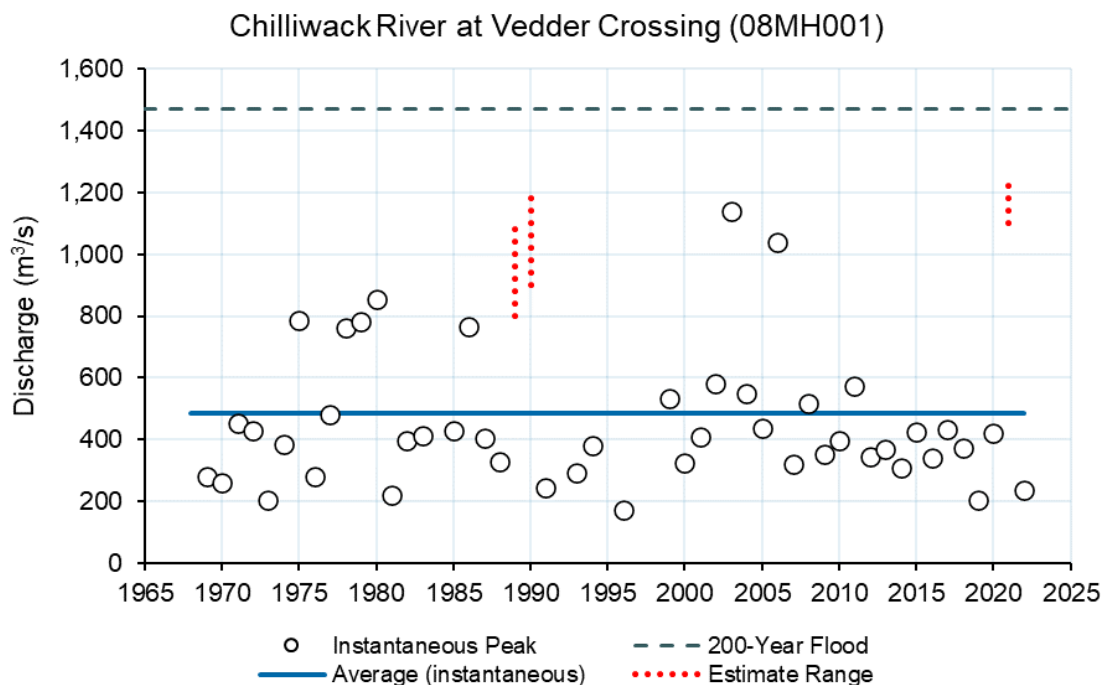
Figure 2.1 Annual maximum instantaneous (peak) discharges published by WSC along with approximate ranges of missing floods from 1989, 1990 and 2021.

The 2021 flood occurred after a 14-year period of lower than average flows between 2007 and 2020 (Figure 2.1). In comparison, the years between 1975 and 1990 were a period of sustained high flows. This cyclical variability is a commonly observed feature of long-term flood records due to multi-year climate oscillations. Similarly, there is a tendency for very high peak flows to cluster together in above-average, multi-year periods.

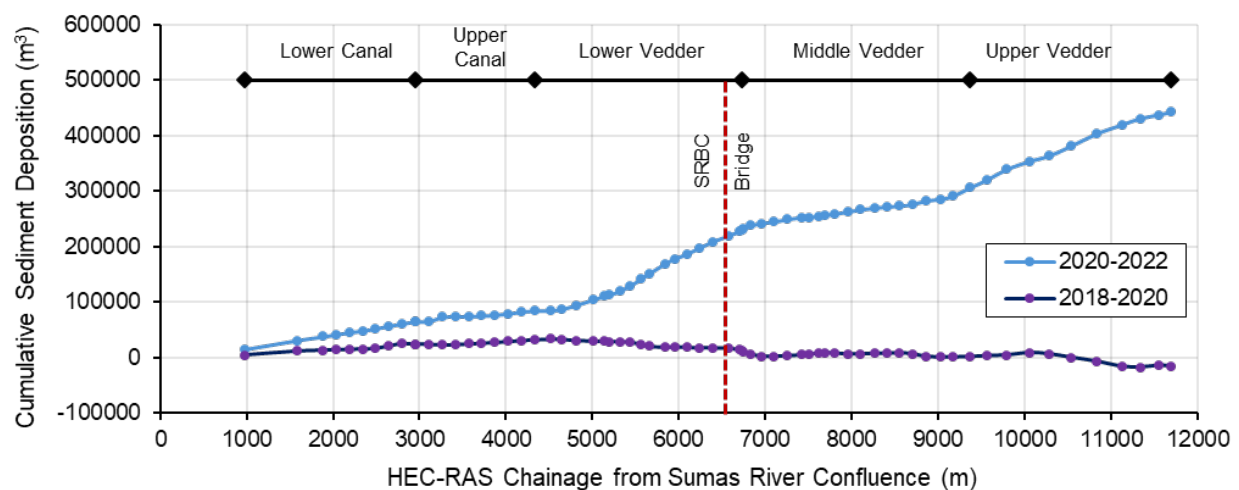
Figure 2.2 Cumulative sediment deposition along Vedder Canal and Vedder River for two periods-2018 to 2020 and 2020 to 2022. All data from KWL (2020) and KWL (2022).

The annual variability in sediment deposition can be illustrated when comparing deposition volumes reported for the two periods 2018 to 2020 and 2020 to 2022 (KWL (2020), KWL (2022)). The cumulative sediment deposition along the Vedder Canal and Vedder River is illustrated in Figure 2.2. There were no sediment removals between 2018 and 2022 which simplifies the comparison between the two periods shown in Figure 2.2.

In the period 2020 to 2022, the flows exceeded 300 m³/s for four days, and the maximum daily discharge exceeded 700 m³/s on 15 November 2021. These high discharge conditions lead to the

Conversely, the period 2018 to 2020 is an example when the sediment inflow at Vedder Crossing was extremely low and the Vedder River experienced net degradation even though no gravel removal occurred. During the 2018 to 2020 period, the highest daily flow was 302 m³/s and the period of highwater lasted only one day. Approximately -49,000 m³ of bed lowering occurred along the Vedder River and 33,000 m³ of deposition occurred in the canal. It is likely that the actual sediment inflow at Vedder Crossing was negligible and that a relatively small quantity of sediment scoured from the Vedder River which was then re-deposited in the canal. The net difference (-16,000 m³) suggests some of the finer sediment may have been transported through the canal into the Fraser River.

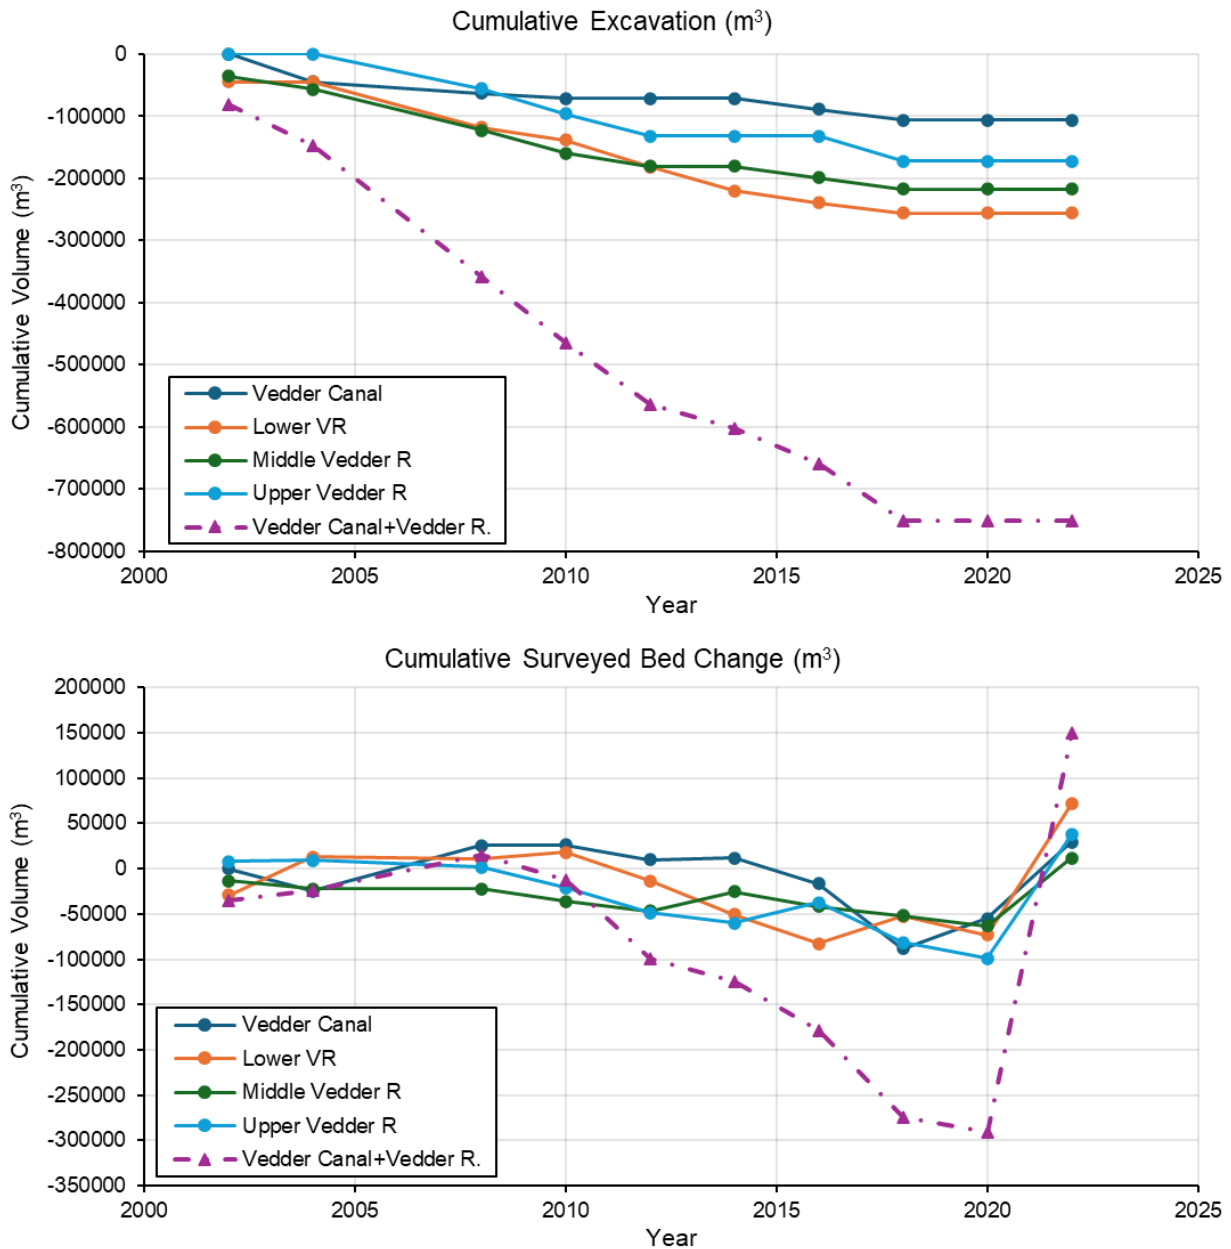
Figure 2.3 Top graph: cumulative gravel excavation volumes from 2000 to 2022. Bottom graph: cumulative bed change volumes surveyed between 2000 to 2022.

The period 2000 to 2020 experienced lower-than-average sediment inflows and lower excavation volumes (except for a removal of 212,717 m³ after the 2006 flood). The cumulative excavation volumes (top graph) and cumulative bed volume changes (bottom graph) are shown in Figure 2.3. Excavated cumulative volume (bottom graph) through time increased from between 2000 to 2018 but then remained steady between 2018 and 2022 as no sediment was removed. The lower graph shows the bed changes between 2000 and 2010 did not show a systematic trend (natural deposition and excavation were approximately equal), then lowered consistently in all reaches between 2010 and 2020. Deposition from the November 2021 flood then re-set the bed to net aggradation of 150,000 m³ relative to the year 2000.

In summary, during the 20 years before the 2021 flood, the Vedder River and Vedder Canal were experiencing a period of net bed lowering which was reversed by the 2021 flood.

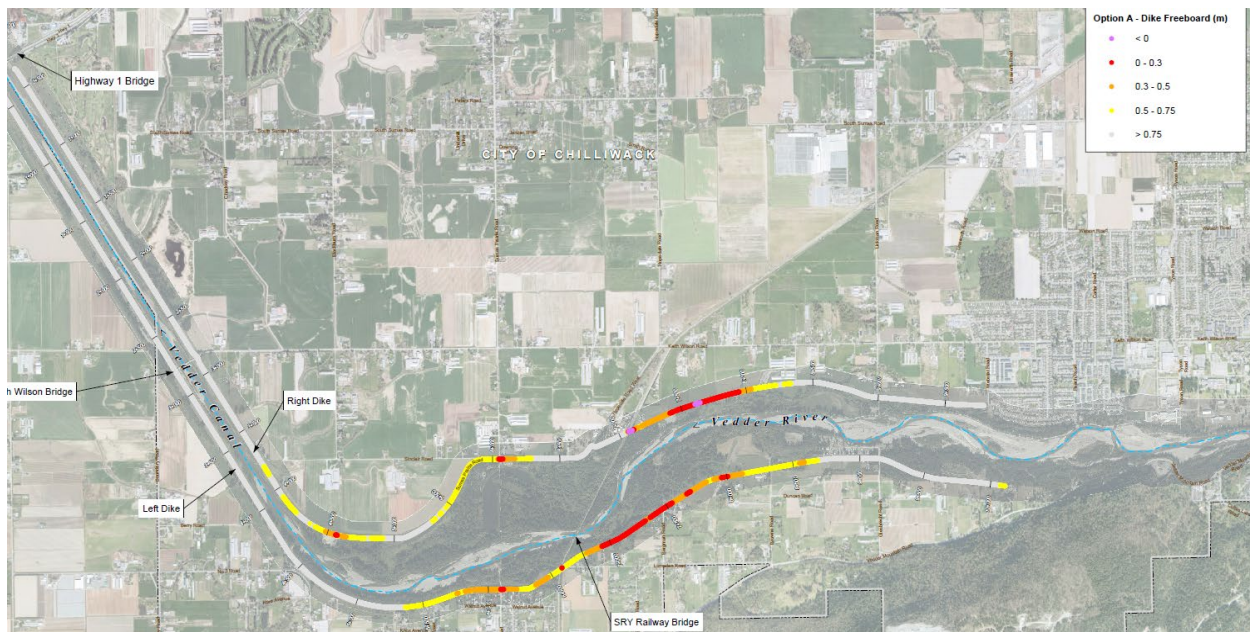
Figure 3.1 Freeboard deficiency 200-year flood condition (KWL 2024; Figure 7-3).

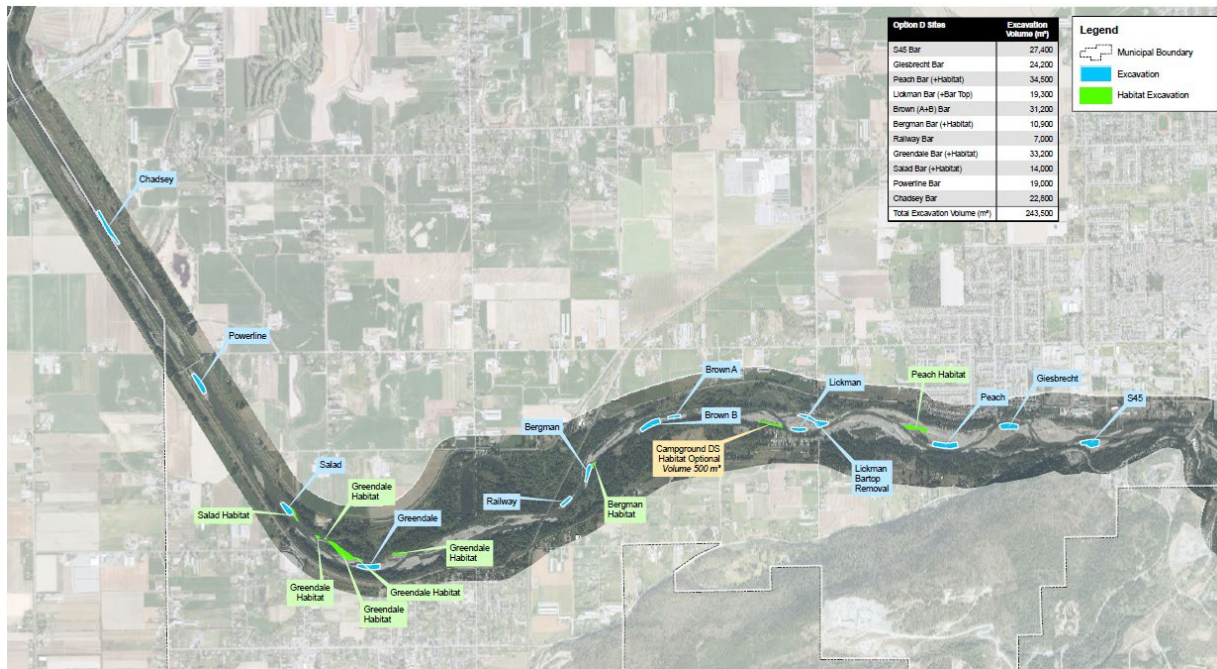
Figure 3.2 Location of gravel removal sites-Option D (KWL 2024; Figure 8-5).

lower Vedder River, four on the middle Vedder River and three on the upper Vedder River(Figure 3.2) . Individual excavation volumes ranged from 7,000 m³ up to 34,500 m³ at Peach Bar).

Figure 3.2 shows the location of the 11 sediment removal sites in KWL's (2024) recommended Option D. Figure 4.3 compares the removals with the 2021 deposition volumes. The three sites in the upper reach (S45, Giesbrecht, Peach) total 86,100 m³ and make up 35% of the total excavated volume. All of these sites are located upstream of the freeboard deficit reach. We assume these excavations will function as sediment traps to reduce the rate of infilling in the middle and lower reaches, but it is difficult to assess

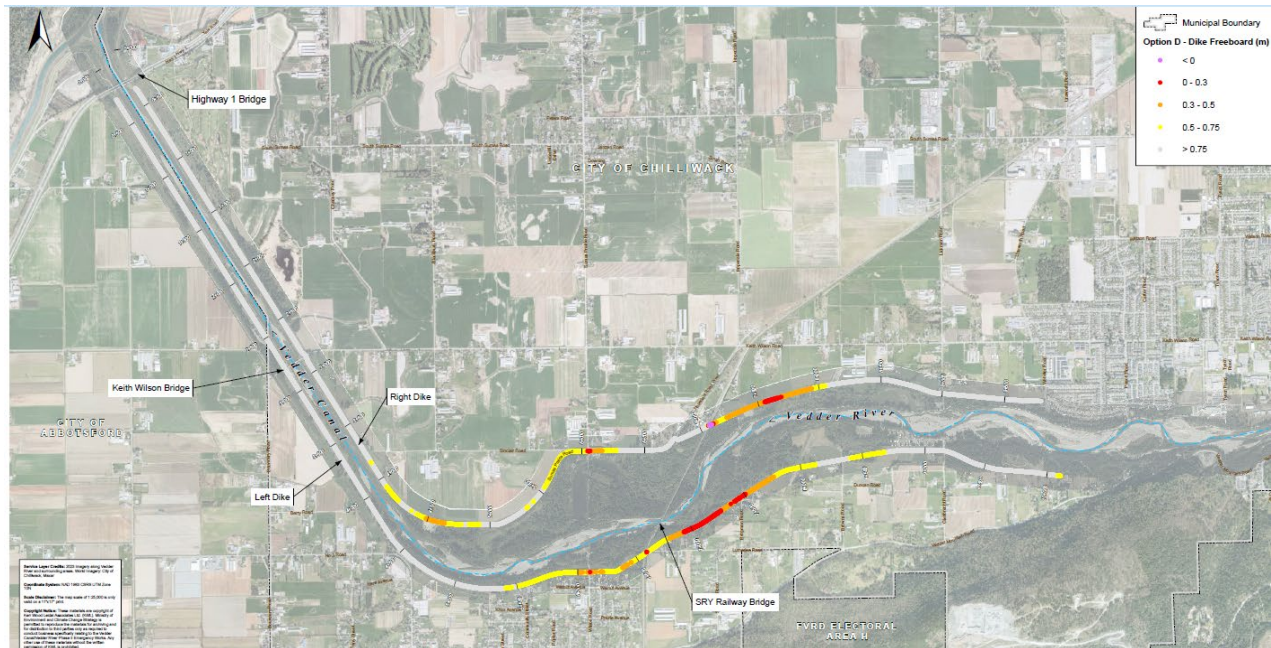
Figure 3.3 Freeboard after Option D (KWL (2024); Figure 8-10).

The freeboard after sediment removal is summarized in Figure 3.3. The KWL (2024) study did not assess how the morphology of the Vedder River is expected to change in response to the sediment removal options. It concluded that a notable response in channel morphology is not expected since the design and location of the sediment removal sites follow previously established guidelines.

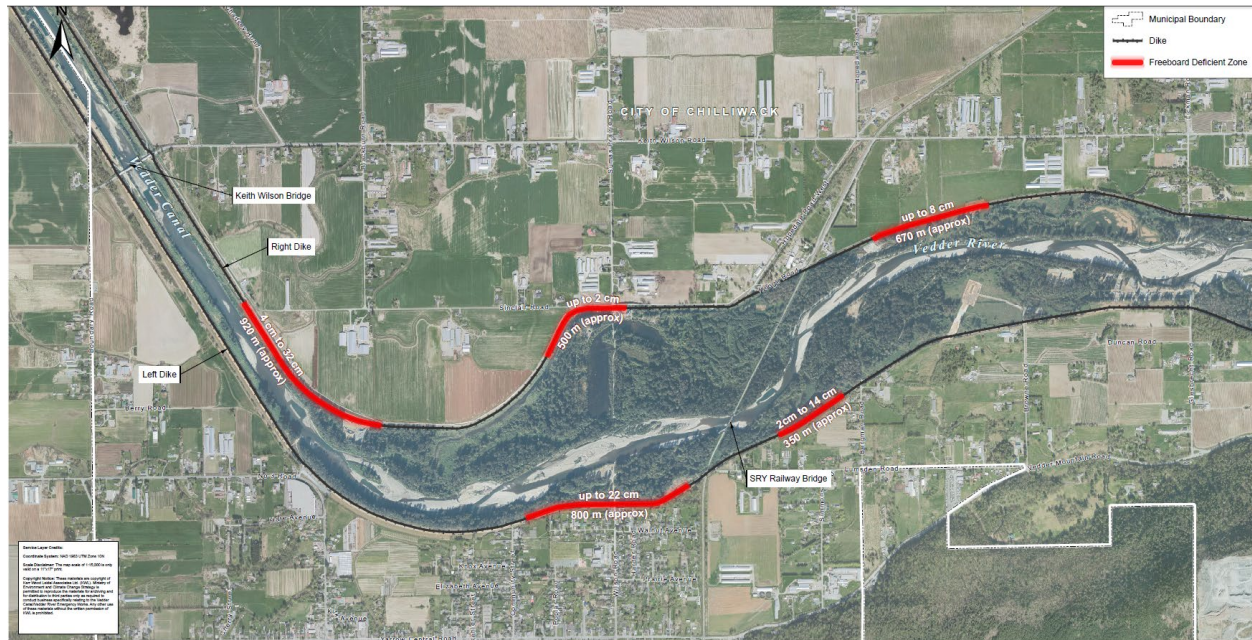
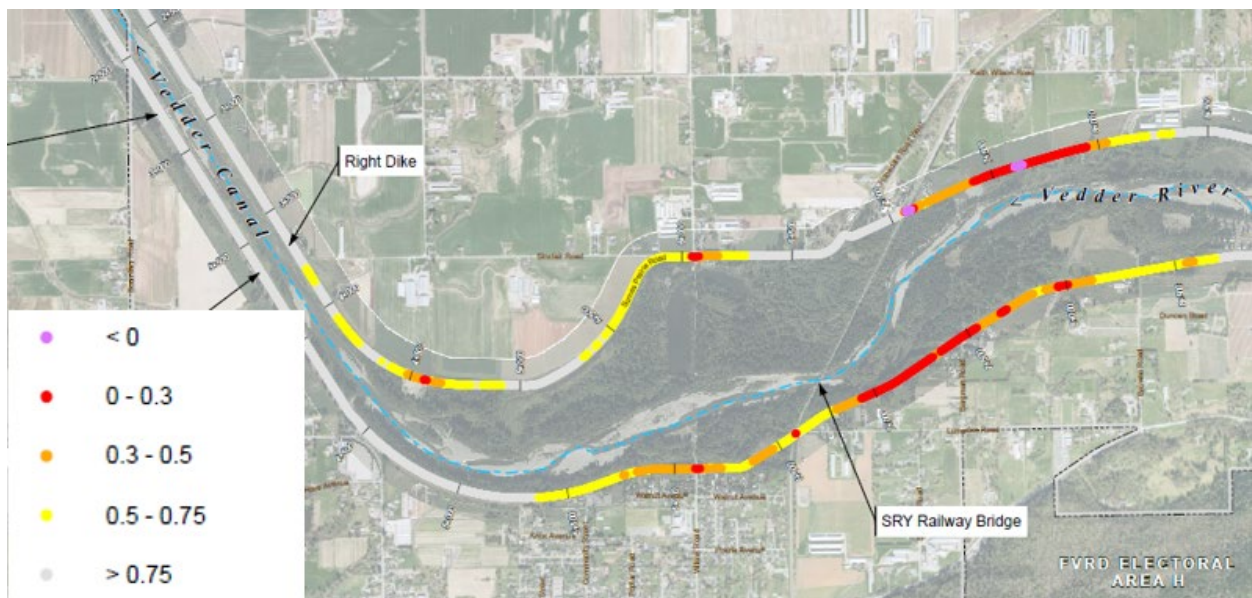
Top: Baseline freeboard deficiency locations from KWL (2023-Figure 6-3). Red lines indicate locations where the freeboard is less than 0.75.

Bottom: Baseline freeboard locations from KWL (2024-Figure 7-3)

Figure 4.1 Comparison of baseline freeboard conditions from 2023 to 2024 flood profiles.

The updated flood profile in KWL (2024) produced substantially higher water levels along the Vedder River in comparison to flood levels reported in KWL (2022) and KWL (2023). The differences are illustrated by comparing the KWL (2023) (top) and KWL (2024) (bottom) freeboard deficient areas in Figure 4.1². KWL (2023) reported that the minimum freeboard was between 0.50 m and 0.67 m along the right dike and between 0.43 m and 0.57 m along the left dike. The freeboard deficiency varied from 0.08 m to 0.25 m along the right dike and 0.18 m to 0.32 m along the left dike. It was also stated that the freeboard prior to the 2021 flood was greater than 0.70 m at all sections.

The updated 2024 flood profile in KWL (2024) shows long sections of the dikes on both sides where the freeboard is less than 0.3 m and two locations on the right bank with freeboard less than 0 m (shaded purple). Although the most serious deficiencies occur upstream of the SRBC railway bridge, there are four locations downstream with freeboard less than 0.3 m.

² Note that the values shown on the top map from KWL (2023) are freeboard deficiencies while the legend on the bottom map shows absolute freeboard values.

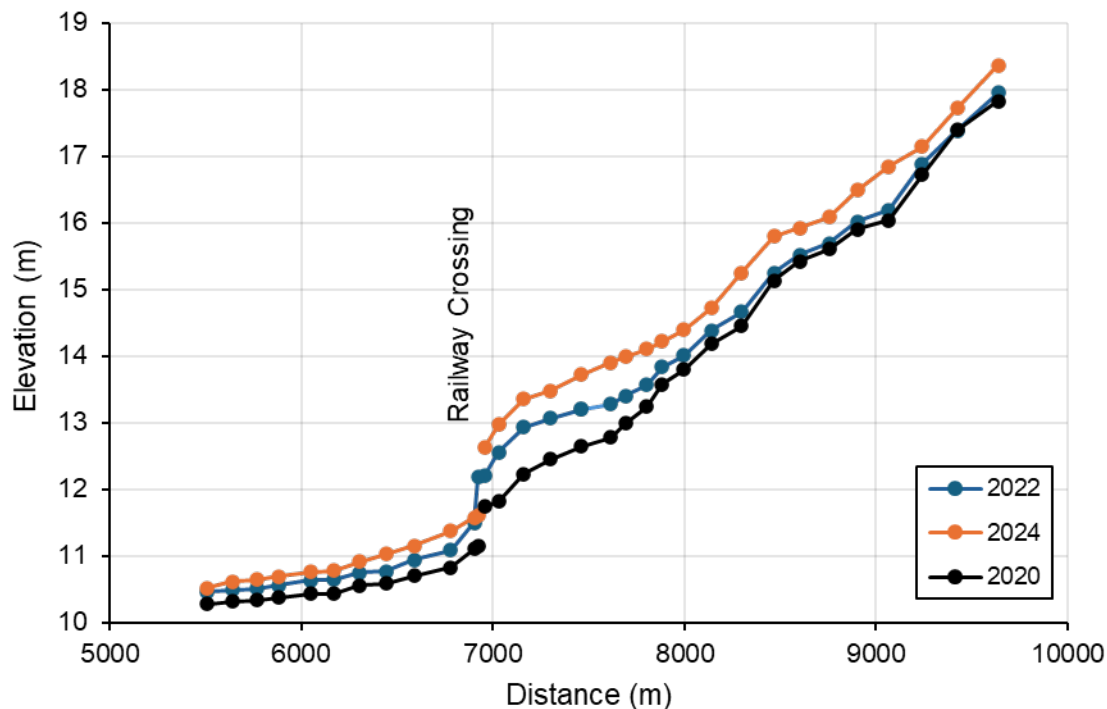
Figure 4.2 Water surface profiles near railway bridge from three hydraulic model runs showing the effect of sediment deposition from the 2021 flood event (2022 versus 2020) and the effect of model calibration (2024 and 2022). All results from KWL (2020), KWL (2022) and KWL (2024).

Figure 4.2 compares the computed flood levels from 2020, 2022 and 2024 to illustrate the sensitivity of the water levels to differences in bed topography (2022 and 2020) and model calibration (2024 and 2022). The flood profiles rise nearly 2 m through the SRBC railway bridge due to the severe constriction and backwater from the bridge. The comparison shows that the reported reduction in freeboard along

the dikes is due to changes (i) sediment deposition from the 2021 flood as well as (ii) changes due to the revised hydraulic model.

Figure 4.2 shows that water levels are sensitive to the local constriction at the bridge. At present, all models assume 200 m³/s of flow leaves the main channel on the right bank upstream of the bridge and passes through the relief channel and culvert at the railway embankment. They also assume 150 m³/s of flow leaves the main channel on the left bank and flows through the trestle at the rail embankment. These assumptions are based on an analysis from Bland (2008). Actual flow splits could be very different, particularly if debris and log jams occur (as in the November 1990 flood). Given these uncertainties, it is not unreasonable to assume that the predicted flood levels could be within ± 0.5 m of actual levels during a design flood event in this reach. This alone justifies the need for attempting to maintain at least 0.75 m of freeboard at all times.

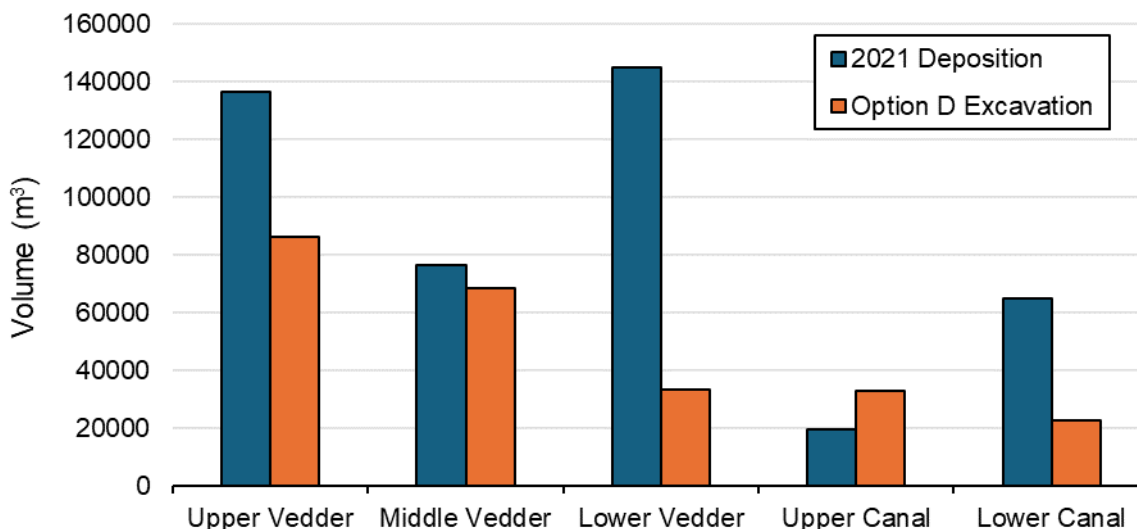
Figure 4.3 Comparison of 2021 sediment deposition and Option D removals by reach.

how efficient the traps will be without additional analysis and monitoring. The remaining excavations should increase the flow conveyance in the freeboard deficit reach to varying degrees until they re-fill with sediment.

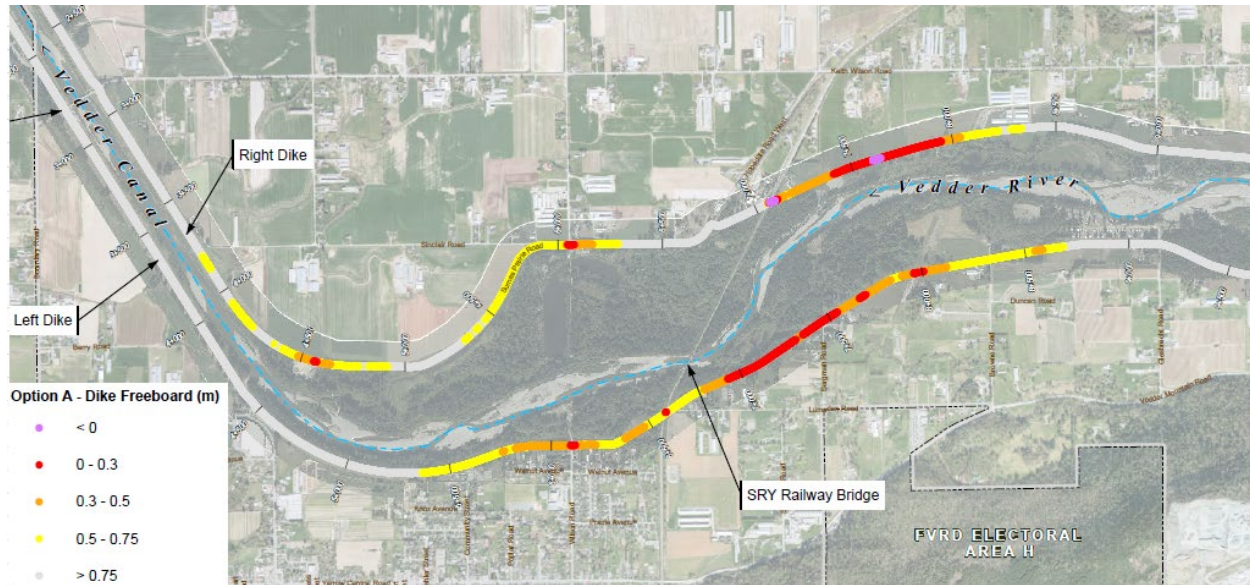
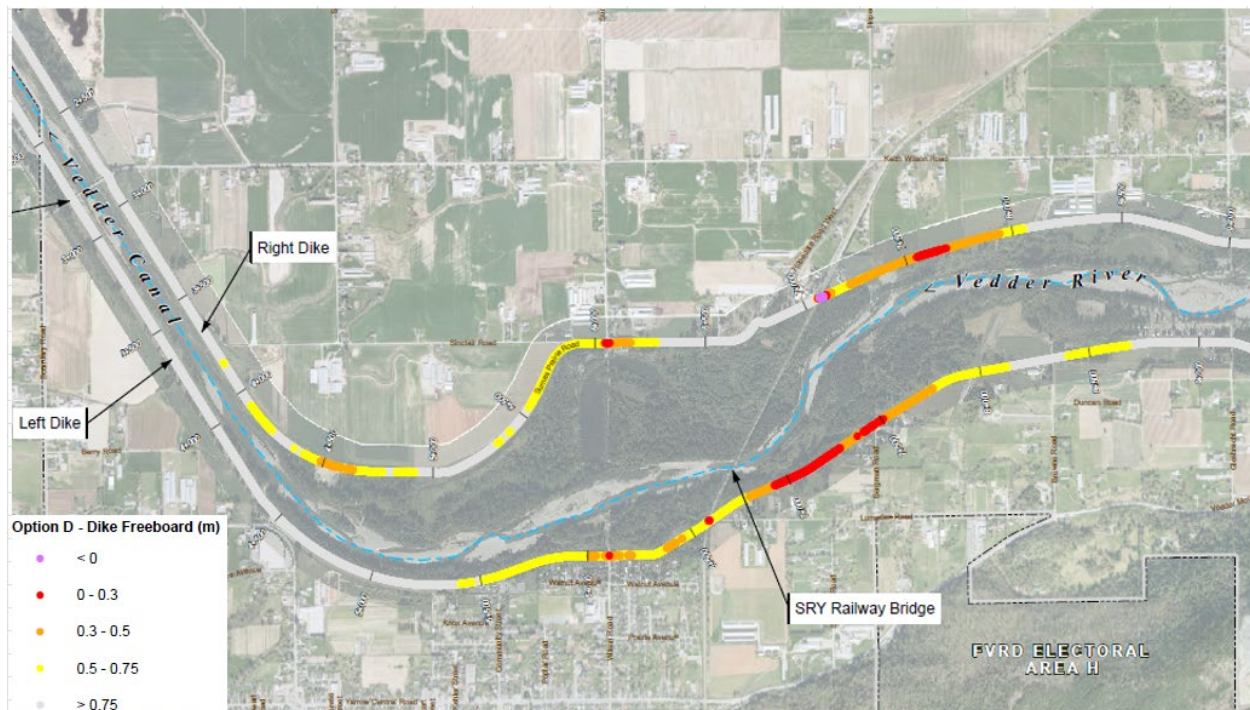
Top: Freeboard with Option A (no sediment removal)

Bottom: Freeboard after Option D (243,500 m3 sediment removal from 11 sites)

Figure 4.4 Comparison of recommended project (Option D) with no excavation (Option A).

Figure 4.4 compares the freeboard conditions along the dike without any sediment removal (top) and after 248,500 m³ of sediment is removed (bottom). Although there is an incremental improvement to the freeboard, other additional measures are still necessary to improve the security against overtopping or breaching. The feasibility of installing temporary flood protection measures (Hesco flood barriers or “Super Sacks”) should be assessed as interim measures while other longer-term solutions are implemented. If additional structural measures (dike raising, floodway improvement) are not carried out then presumably another large removal will be required in 2026.

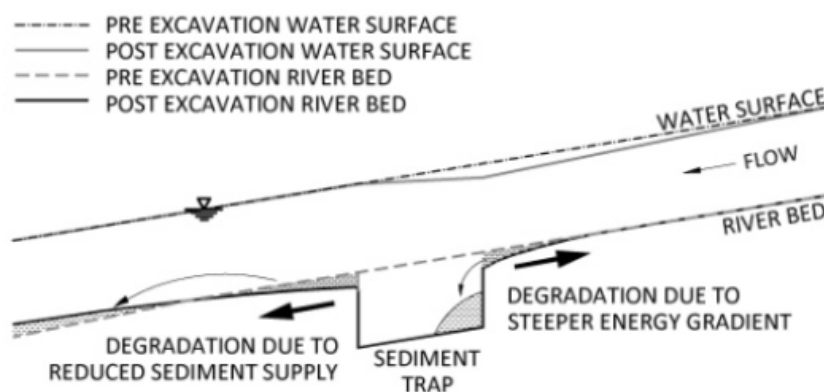
Figure 5.1 Effect of sediment removals on stream profiles (from McLean et al. (2013)).

Studies to predict the effects of sediment excavations on river morphology have been carried out for several decades (de Vries, 1985). The main sediment transport processes in an idealized excavation are illustrated qualitatively in Figure 5.1. In this case, the incoming sediment is trapped in the deepened channel, reducing the supply to the channel downstream. This results in a downstream progressing wave of bed lowering or degradation. The excavation will gradually fill-in from upstream to downstream, restoring the sediment balance downstream. At the the upstream end, the process is different. The deeper flow in the excavation creates lower velocities, which flattens the water surface slope through it, resulting in a local steepening of the water surface upstream. This “draw-down” effect will induce upstream progressing degradation (head cutting).

The magnitude of degradation depends on the water level lowering at the upstream end of the excavation and on the coarseness of the riverbed material. If the magnitude of water level lowering is small and the riverbed is coarse, degradation is likely to be small. On gravel bed rivers with complex planforms a range of other potential impacts have been documented by (Rempel, 2004) and Church et al. (2001). One impact that is particularly relevant to the Vedder River, is the observation that gravel removal from the river channel may accelerate erosion and sediment transport locally in the short term.

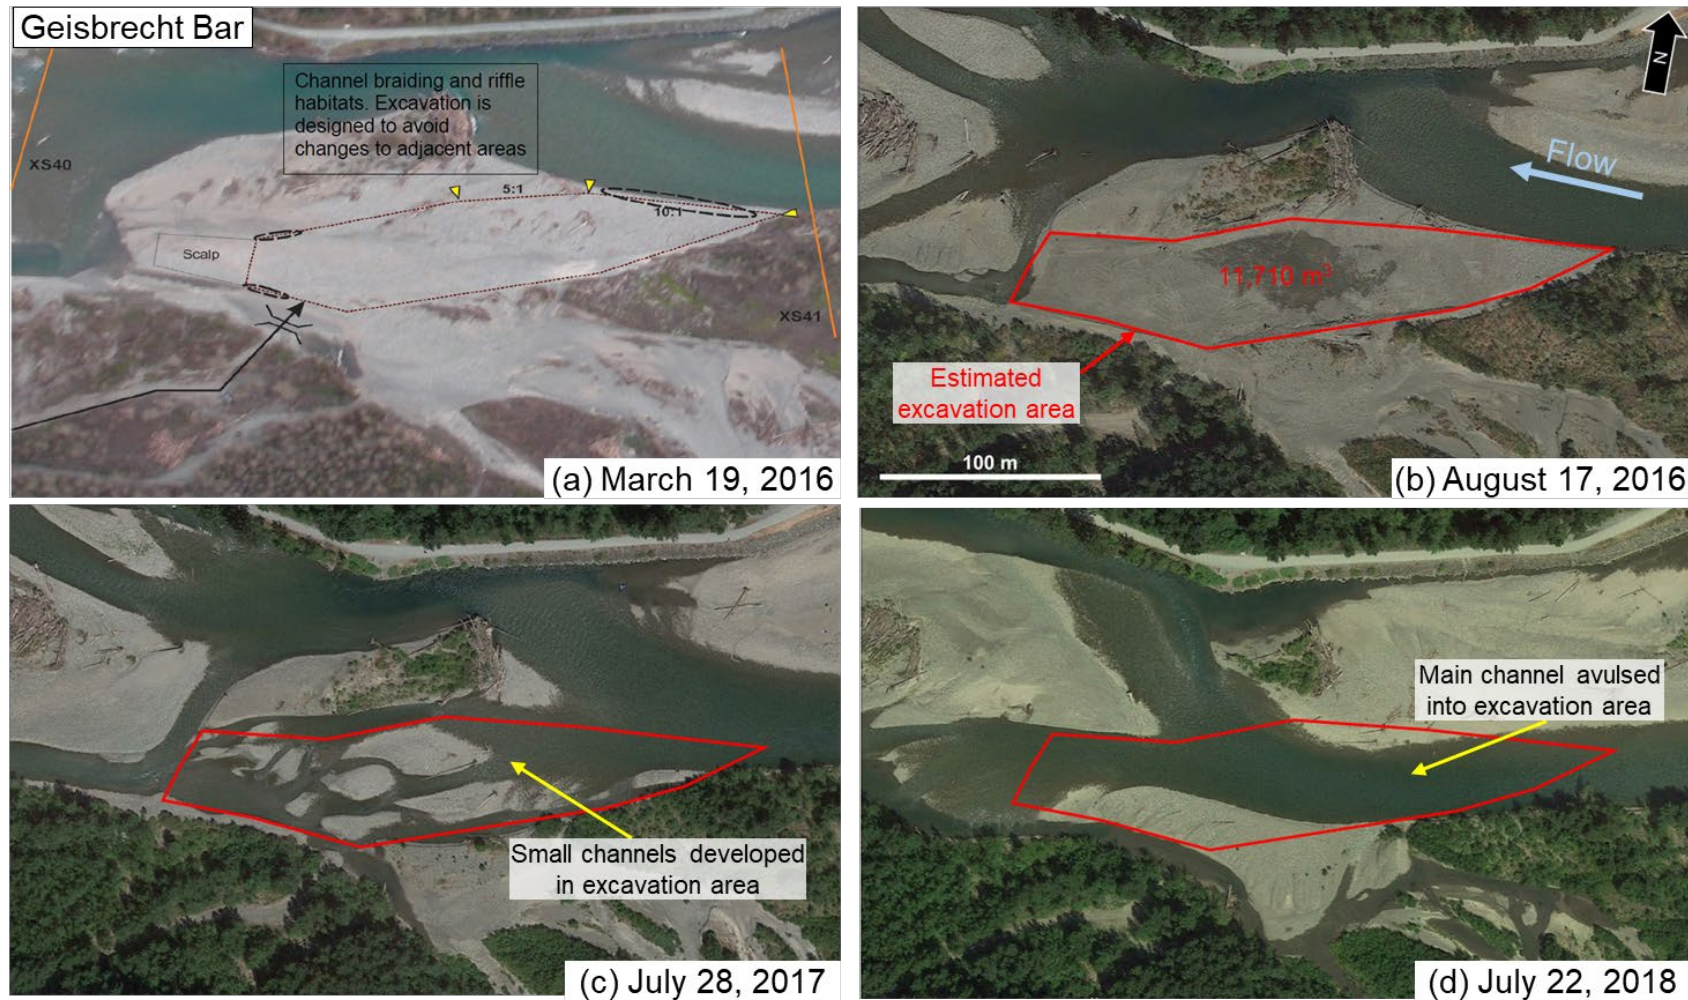
Figure 5.2 Giesbrecht Bar on (a) March 19, 2016, (b) August 17, 2016, (c) July 28, 2017, and (d) July 22, 2018. Aerial imagery in (a) is from Nova Pacific (2016) while satellite images in (b) to (d) are from Google Earth. Sediment removal here occurred between August 10 and August 17, 2016. The extent of the removal can be seen in panel (b).

The bar-scale morphological response varied at the 2016 sediment removal sites, but in all the cases the impact of the excavation area was visible in the latter half of the 2017 freshet (July 2017) (Appendix A). The 2016 removal at Giesbrecht bar appears to be responsible for some substantial morphological change. An avulsion occurred between August 2016 and July 2018, as the main channel shifted its position and occupied the area of sediment removal (Figure 5.2).

These images illustrate how the bars and channel have responded to excavations during a period of low floods and low sediment inflows. During larger floods the channel changes will occur more rapidly with increased sediment transport. If the excavations fill relatively quickly, their effect on the flood profile will be less than the “fixed bed” hydraulic models indicate.

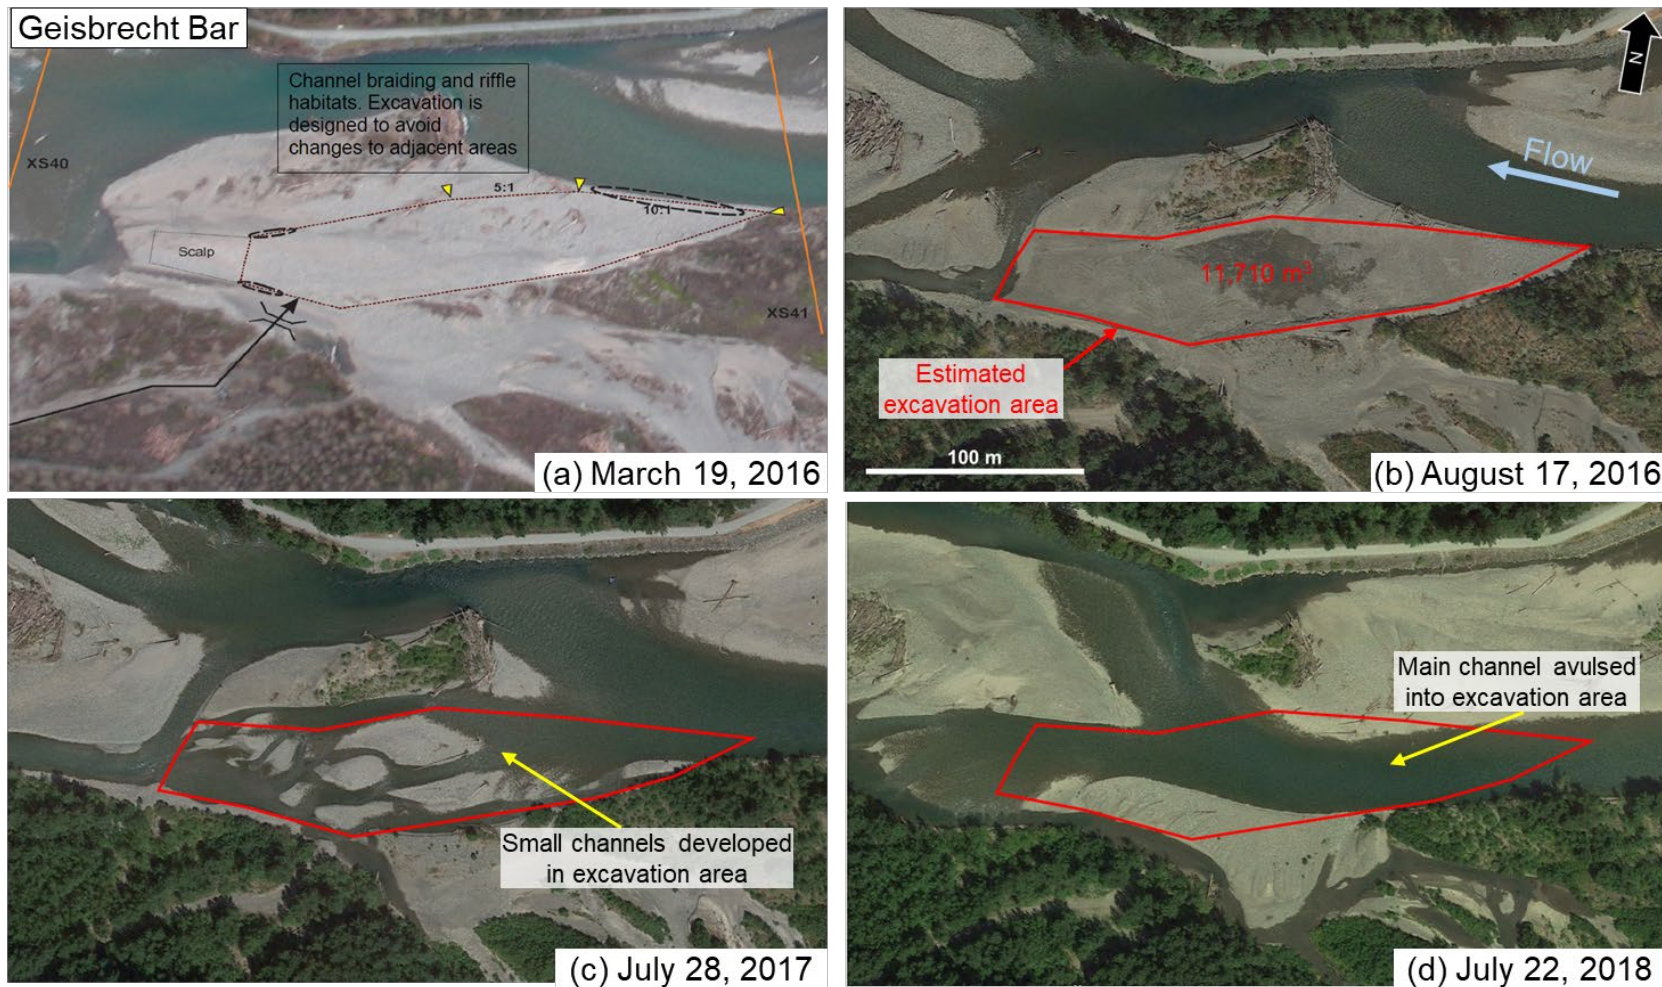
Figure A.1 Giesbrecht Bar on (a) March 19, 2016, (b) August 17, 2016, (c) July 28, 2017, and (d) July 22, 2018. Aerial imagery in (a) is from Nova Pacific (2016) while satellite images in (b) to (d) are from Google Earth. Sediment removal here occurred between August 10 and August 17, 2016. The extent of the removal can be seen in panel (b).

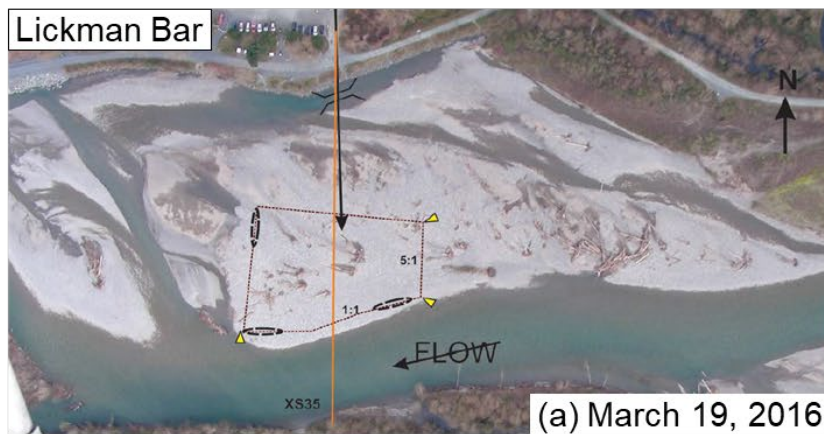
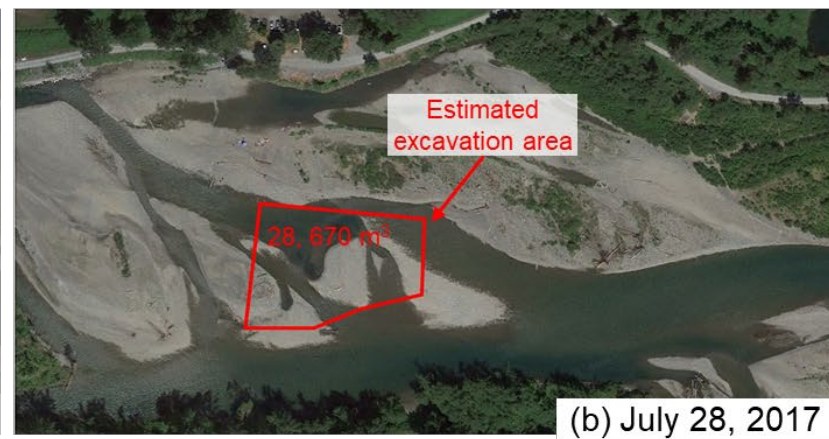
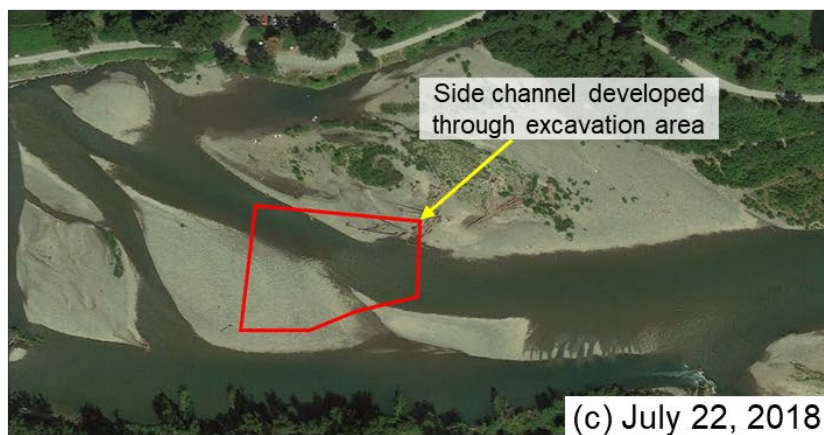
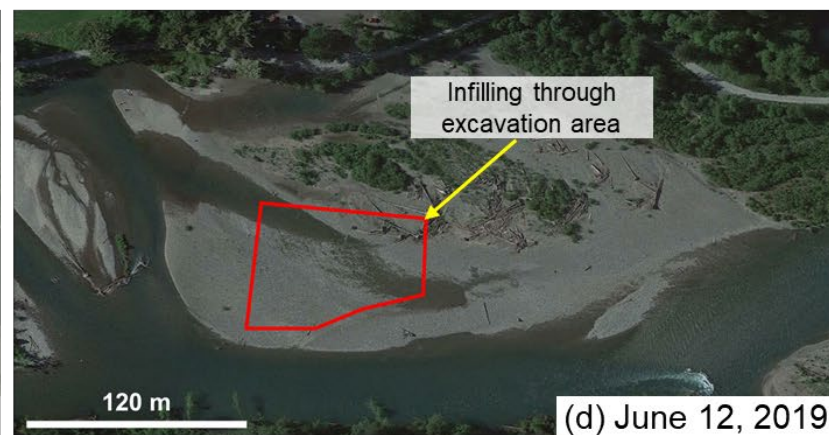
Figure A.2 Lickman Bar on (a) March 19, 2016, (b) July 28, 2017, (c) July 22, 2018, and (d) June 12, 2019. Aerial imagery in (a) is from Nova Pacific (2016) while satellite images in (b) to (d) are from Google Earth. Sediment removal here occurred between September 9 and September 27, 2016. There is no imagery available directly following the removal

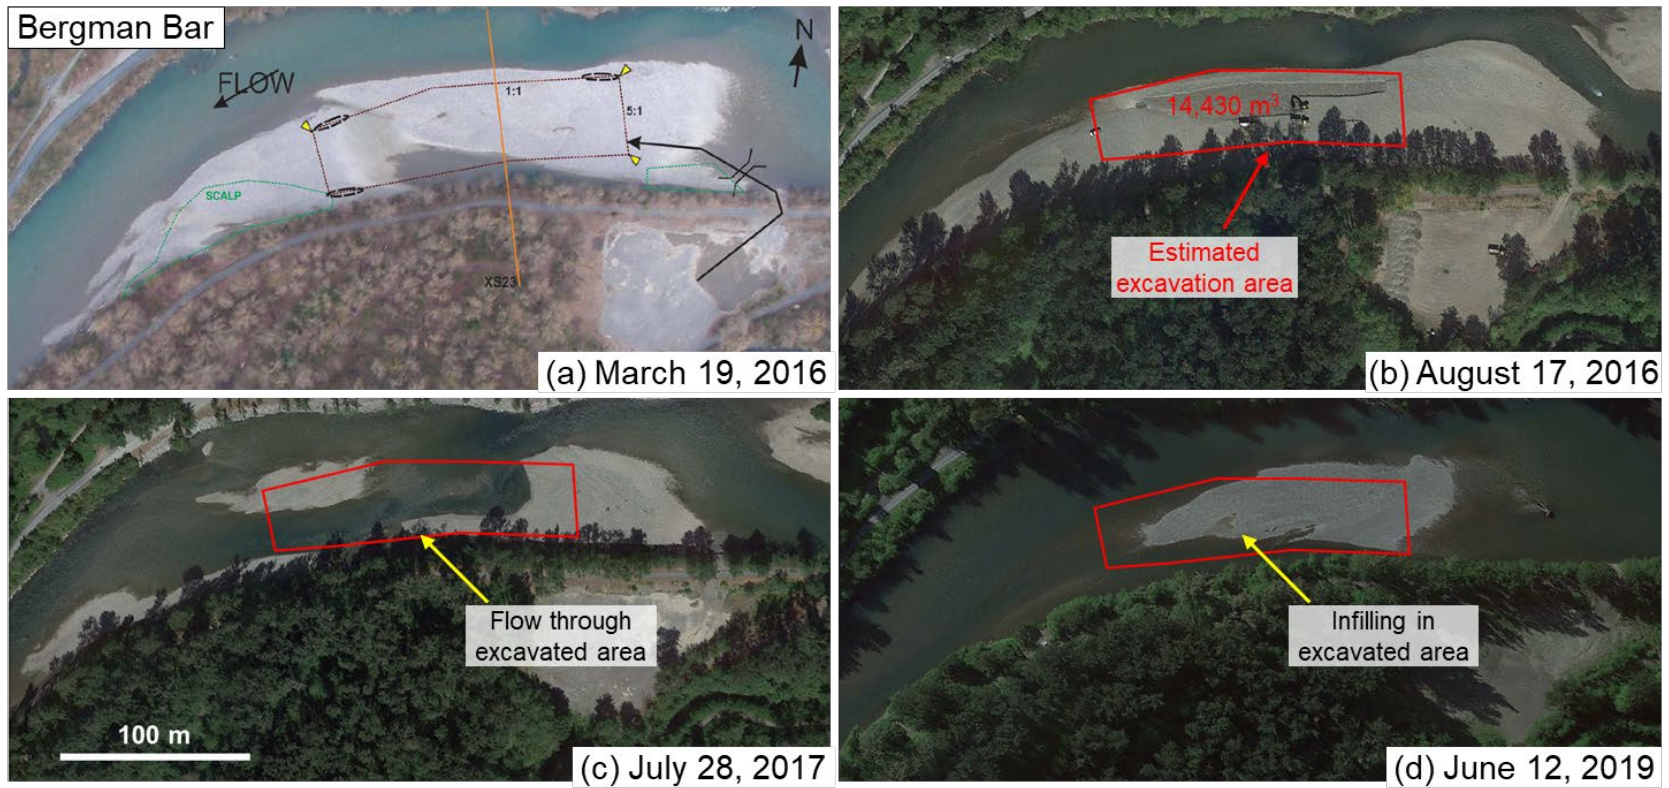
Figure A.3 Bergman Bar on (a) March 19, 2016, (b) August 17, 2016, (c) July 28, 2017, and (d) June 12, 2019. Aerial imagery in (a) is from Nova Pacific (2016) while satellite images in (b) to (d) are from Google Earth. Sediment removal here occurred between August 17 and August 26, 2016. The image in (b) occurred during the sediment removal.

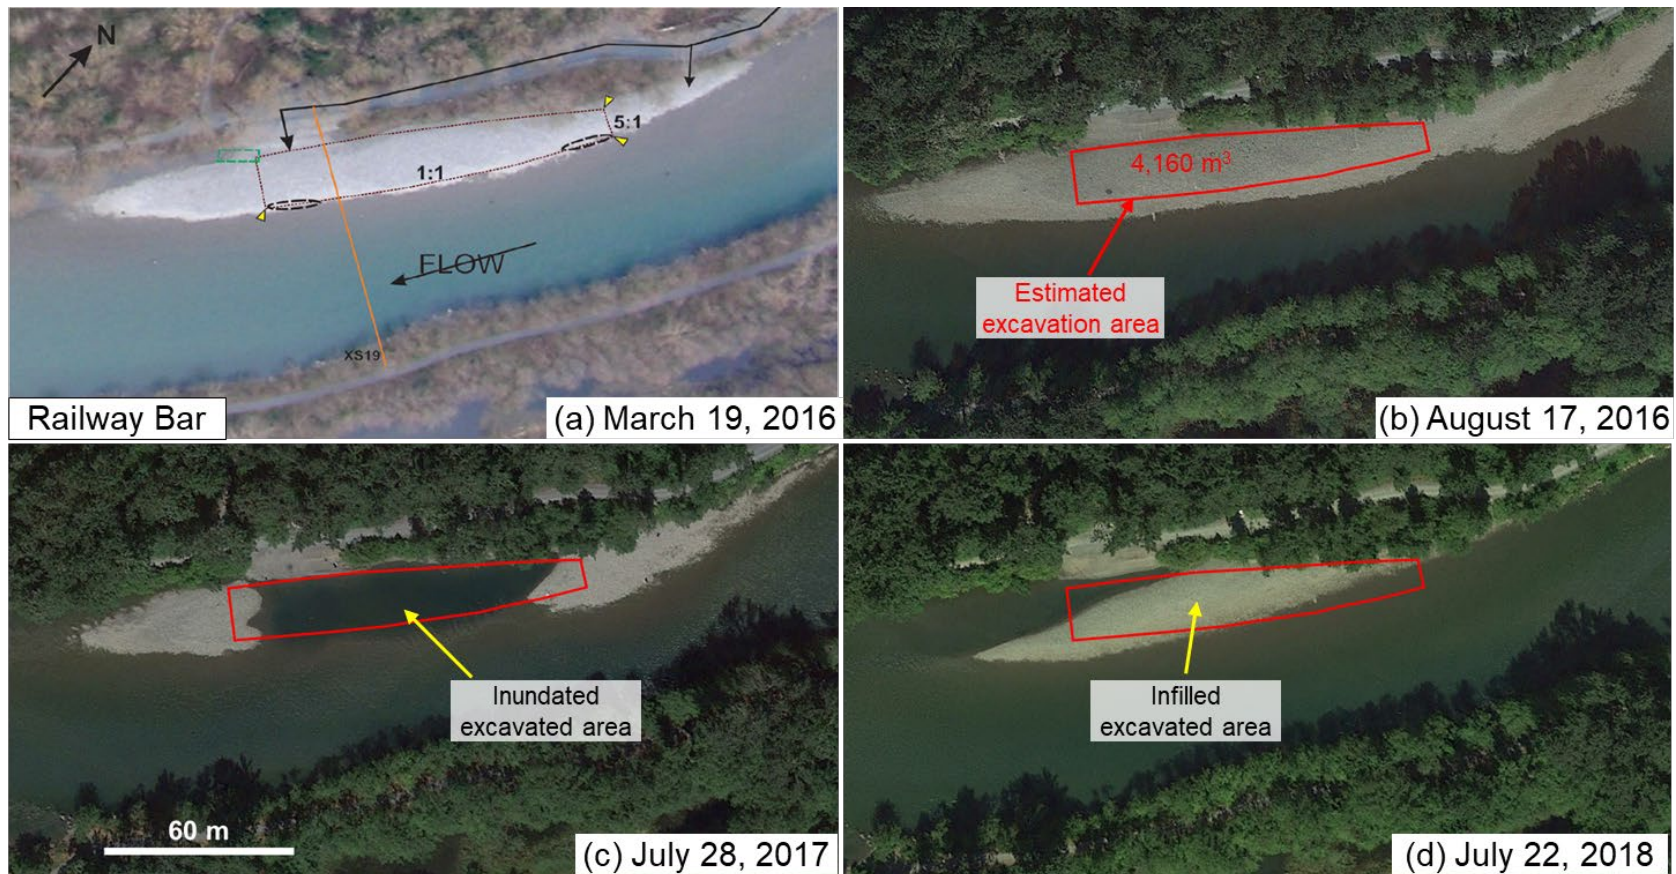
Figure A.4 Railway Bar on (a) March 19, 2016, (b) August 17, 2016, (c) July 28, 2017, and (d) July 22, 2018. Aerial imagery in (a) is from Nova Pacific (2016) while satellite images in (b) to (d) are from Google Earth. Sediment removal occurred between September 9 and September 13, 2016. The image in (b) is before the sediment removal.
