Review of 2024 Vedder River Gravel Removal Plan

April 18, 2024
Final Report, Rev. 0

**BC Ministry of Environment and Climate Change
Strategy**
Environmental Protection Division,
Victoria, BC

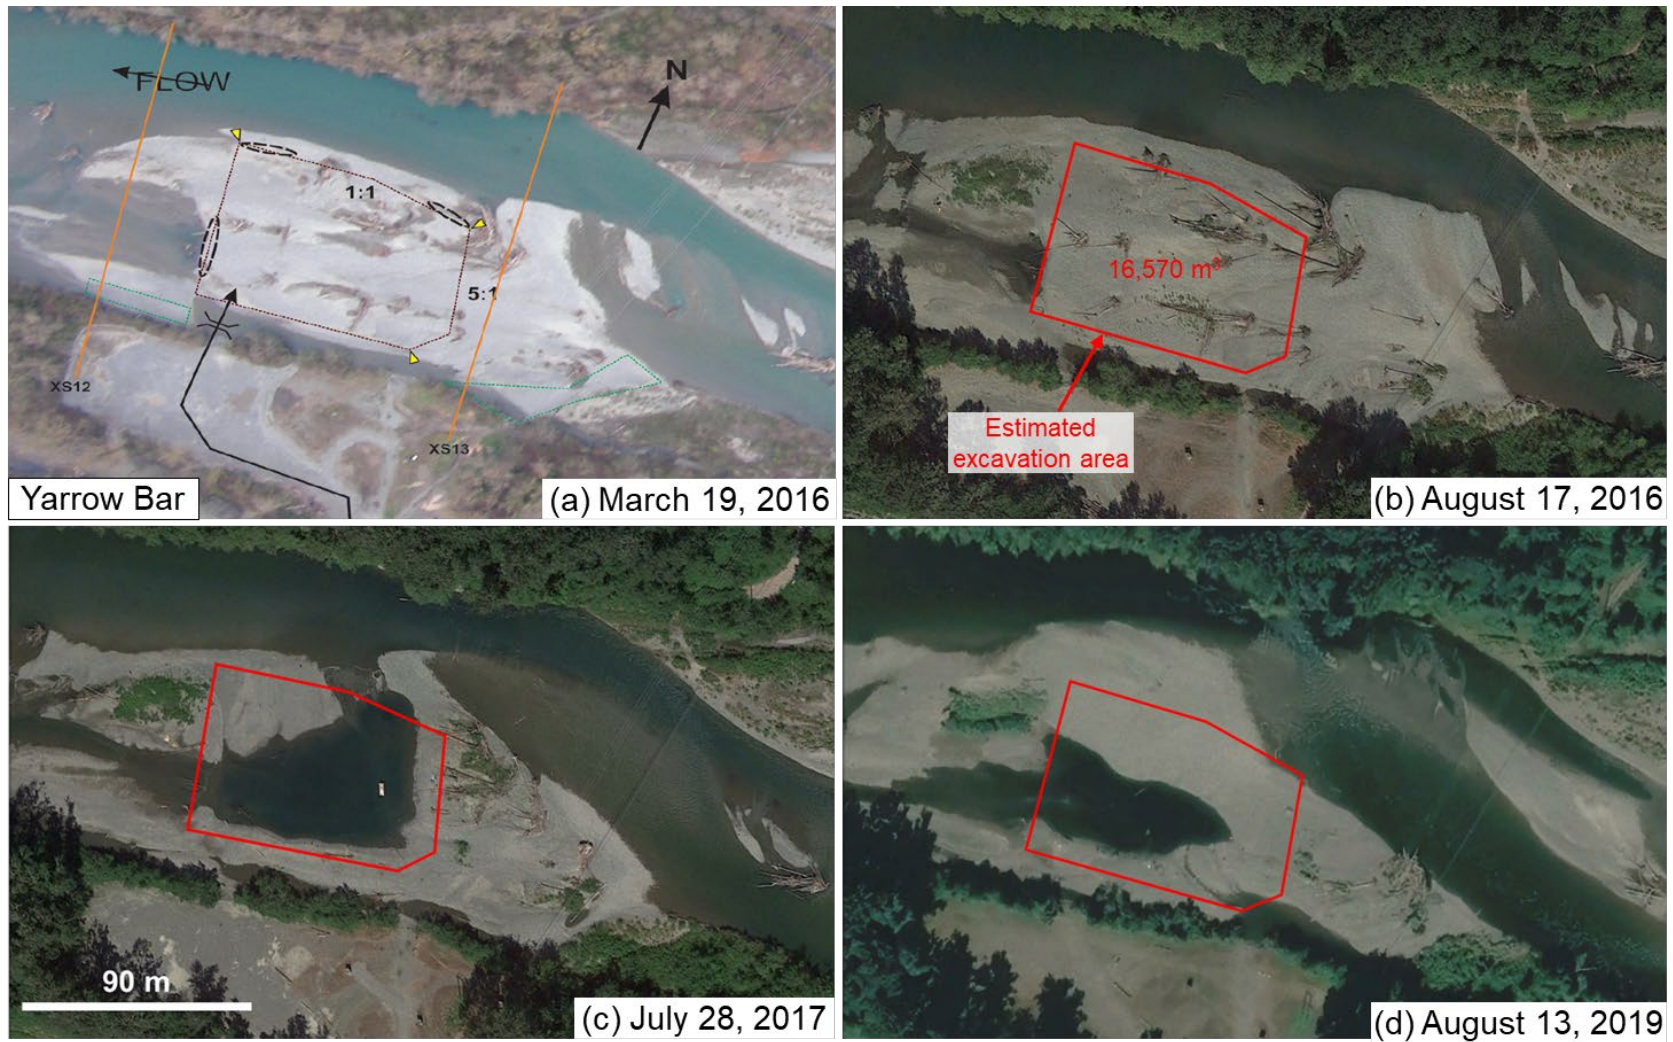
Figure A.5 Yarrow Bar on (a) March 19, 2016, (b) August 17, 2016, (c) July 28, 2017, and (d) August 13, 2019. Aerial imagery in (a) is from Nova Pacific (2016) while satellite images in (b) to (d) are from Google Earth. Sediment removal here occurred between August 27 and September 8, 2016. The image in (b) is before the sediment removal.

At Yarrow Bar, the pit left behind from the 2016 removal left a wetted area on the bar that was still present in August 2019, suggesting that infill in this location was limited (Appendix A, Figure A5). Other locations, such as Railway Bar (Appendix A, Figure A4), appear to return to a similar morphology as the pre-2016 removal through infilling after a couple of years. However, the pit of the removal remained exposed through the winter and 2017 freshet, so normal sediment transport processes were affected for at least one year.

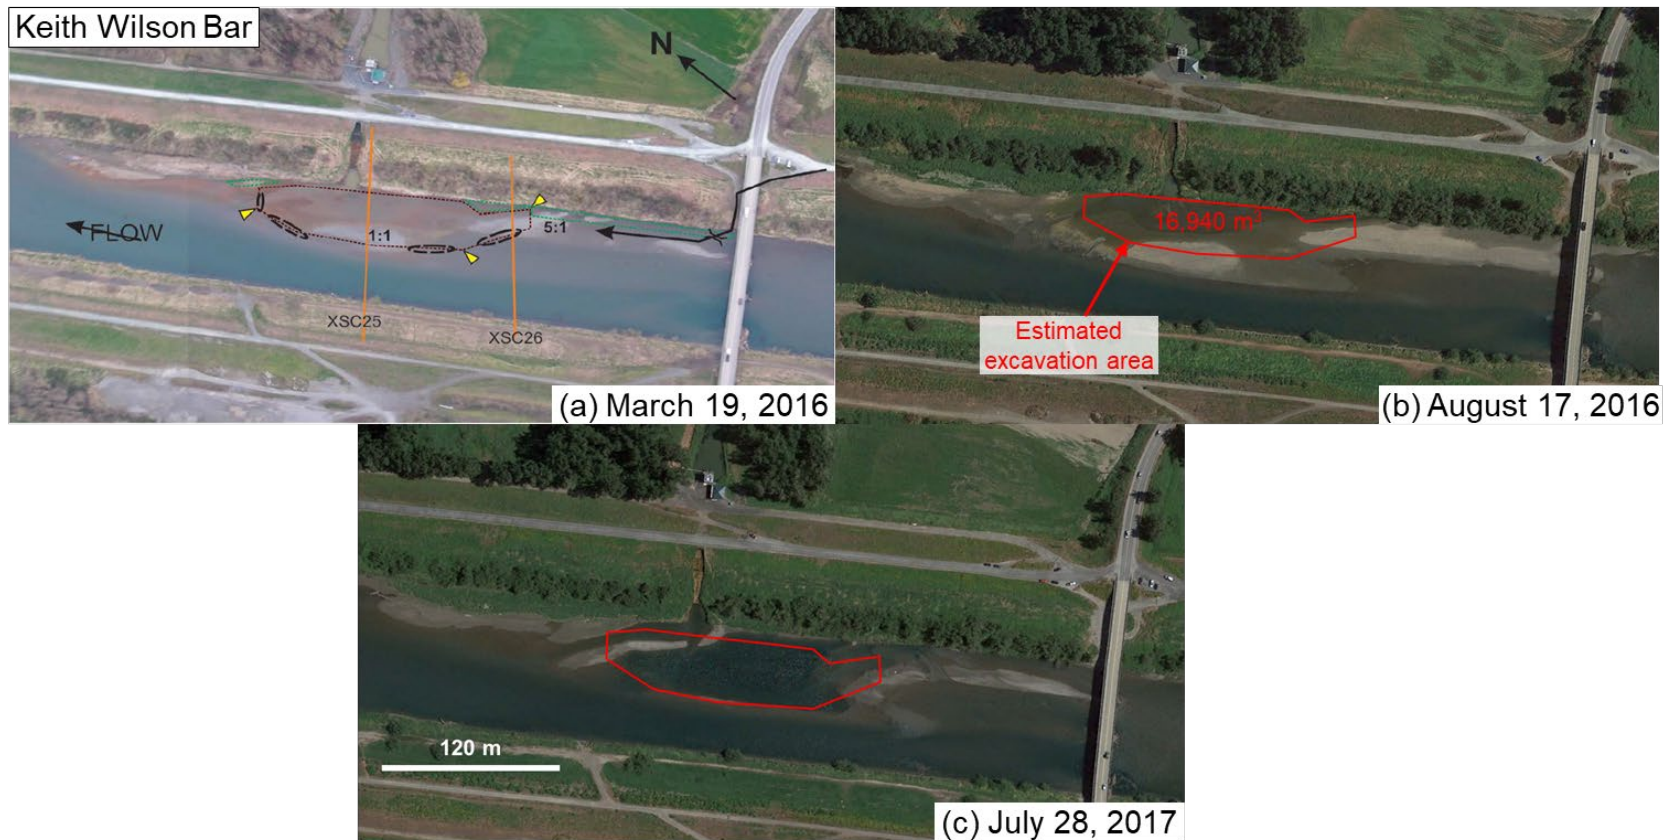
Figure A.6 Keith Wilson Bar on (a) March 19, 2016, (b) August 17, 2016, and (c) July 28, 2017. Aerial imagery in (a) is from Nova Pacific (2016) while satellite images in (b) and (c) are from Google Earth. Sediment removal here occurred between September 6 and September 29, 2016. The image in (b) occurred before the sediment removal. There is no imagery of the exposed bar in the years following 2017 due to high water levels.
